# PROBLEMS, CAUSES, AND CURES

This technical publication was developed by subject matter experts serving on the Problems, Causes, and Cures Taskforce, and on the NWFA Technical Standards and Publications Committee, using reliable principles, with research of all available wood flooring data, and in consultation with leading industry authorities.

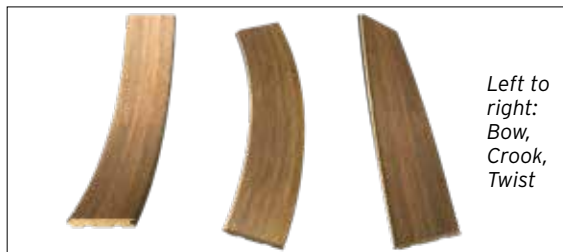
**Bow** - A deviation in the lengthwise flatness of a board, measured end to end.

- Solid wood flooring: Bow occurs when one side of the floor board shrinks more in length than the other. It causes the lengthwise curvature of the plank that resembles a bow used in archery. Because longitudinal shrinkage in solid wood is minimal, bow is normally not an issue that affects installation.
- Engineered wood flooring: Bow occurs when the wear layer and the core begin to shrink in opposing lengthwise directions, forcing the uninstalled planks to bow. Manufacturer and industry standards (HPVA) dictate tolerances and milling requirements for the amount of bow allowed in an engineered wood floor at the time of manufacture. This may or may not coincide

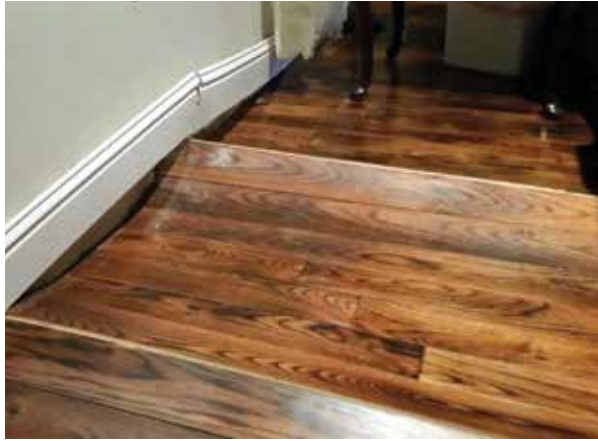
## Buckling

**DEFINITION:** The wood flooring has separated or lifted from the subfloor.

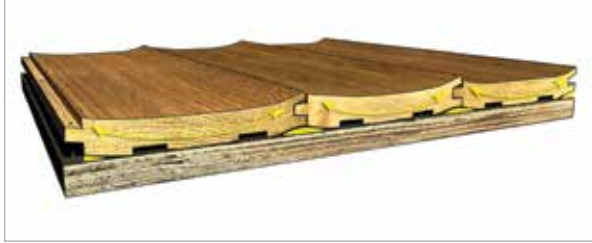
## Cupping

**DEFINITION:** A concave or dished appearance of individual boards with the edges of the board raised higher than the center. This is also a type of warp.

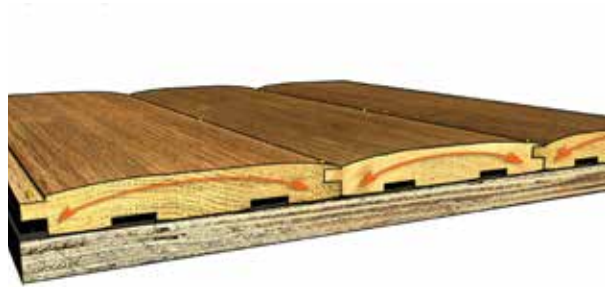
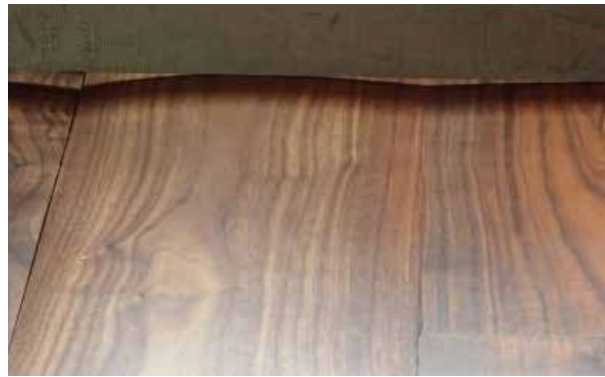
## Crowning

**DEFINITION:** A convex or crowned appearance of individual boards with the center of the board higher than the edges. This can also be a type of warp.

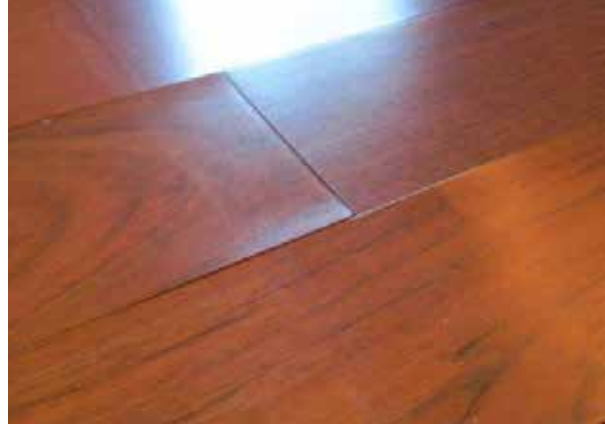
**Dry Cupping**

**DEFINITION:** A concave or dished appearance of individual engineered flooring planks with the edges raised higher than the center.

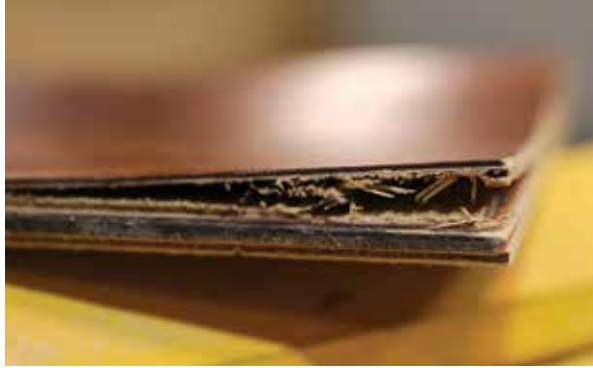
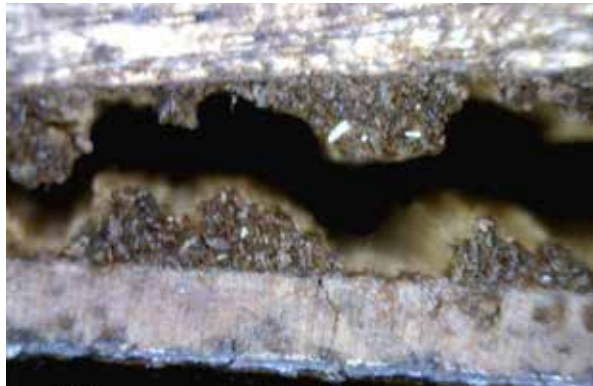
## Wood Shear (Engineered Flooring)

**DEFINITION:** External stresses exceeding the strength of the wood fibers within an individual plank of engineered flooring, resulting in the wood fibers being torn apart. When examining this type of failure in an engineered wood flooring plank, wood fibers will be visible at the point of separation, remaining bonded to the adhesive layer.

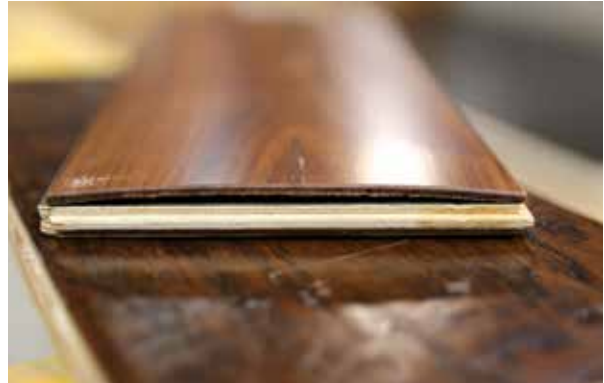
## Delamination/ Glue-Line Separation (Engineered Flooring)

**DEFINITION:** Engineered flooring is manufactured by adhering several layers/plies together. The separation of two layers/plies within a piece of engineered flooring due to the lack of an adhesive bond is typically identified as a clean separation at the glue-line. Adhesive bond failure is unrelated to inadequate relative humidity levels.

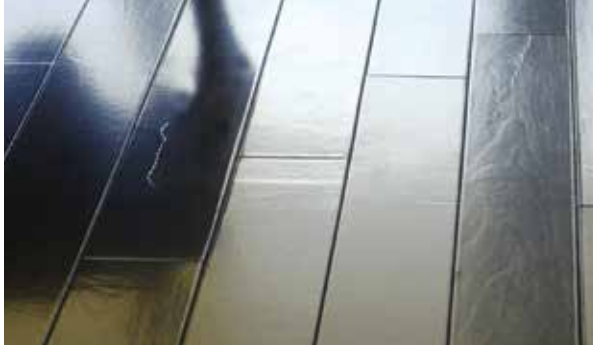
## Telegraphing Core Material (Engineered Flooring)

**DEFINITION:** Visible patterns on the surface of the wood floor plank that resembles variations in the engineered flooring core material.

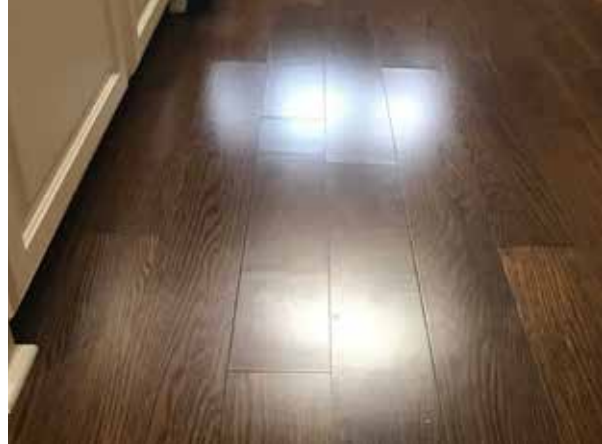
## Endlift/Ski (Engineered Flooring)

**DEFINITION:** A condition where the ends of installed engineered wood flooring boards deviate from the flat plane and appear raised or curved upward.

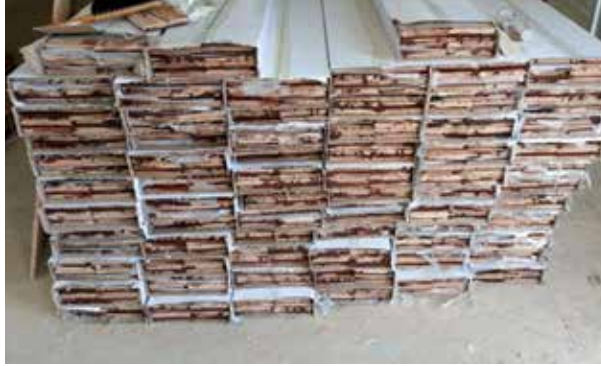
## End-Swell/Flared-Ends (Solid Flooring)

**DEFINITION:** A condition where the ends of solid wood flooring boards deviate from the flat plane and/or parallel plane, and may appear wider or thicker than the rest of the board.

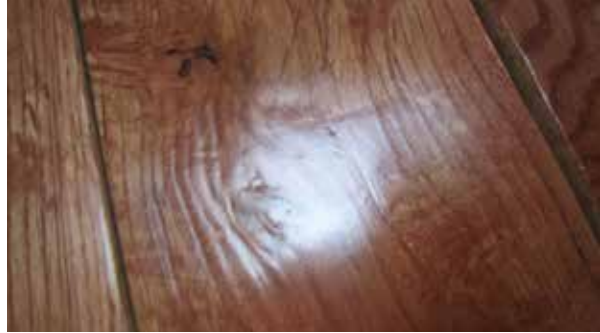
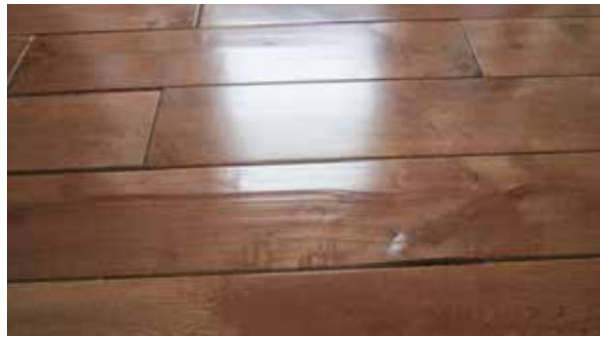
## Reaction or Juvenile Wood

**DEFINITION:** Natural and unique features, properties, and growth patterns in wood that cause it to appear and perform non-traditionally, resulting in distortions from non-uniform swelling and shrinking.

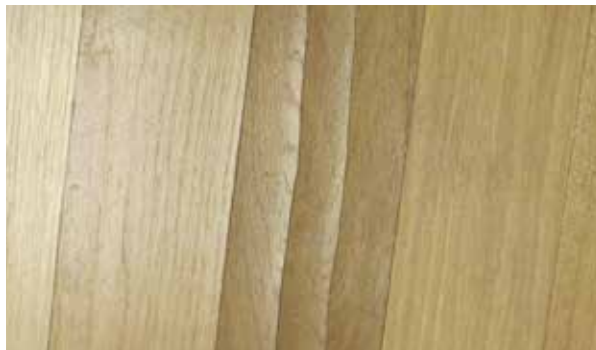
**Surface-Checks** - Surface checks are separations in the wood fibers that usually occur in, or adjacent to, the wood rays on the faces of plainsawn (flatsawn) boards. These separations occur during the early phases of the drying process where the external and internal stresses cause the wood to tear itself apart.

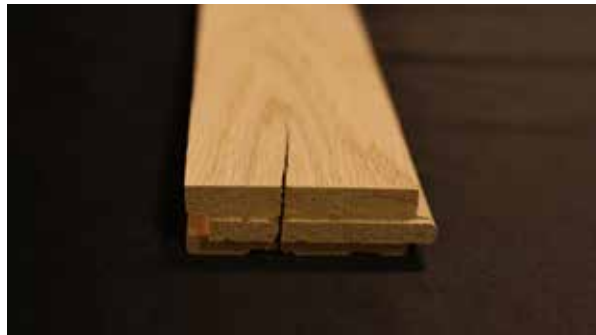
**End-Checks** - Like surface checks, end checks occur in, or adjacent to, the wood rays, but on the ends of the boards rather than the face. These separations occur due to the normal movement of moisture along the length of the boards, where the ends of the boards dry more rapidly leading to stress fractures on the ends of the boards.

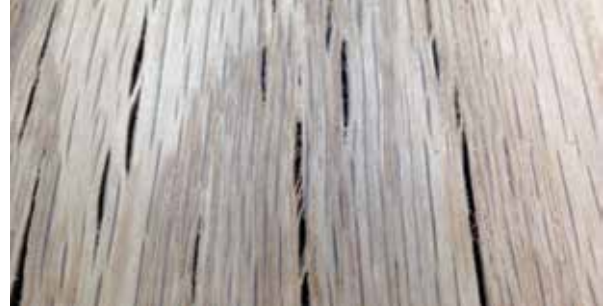
**Internal Checks (Honeycomb)** - An internal defect in the wood that may not be visible on the surface of the board, but occurs in the core (inner part of the board) of solid boards. These checks can become exposed when the boards are sanded or milled. They can also become exposed on the surface of the board with a loss in moisture or changes in RH after installation.

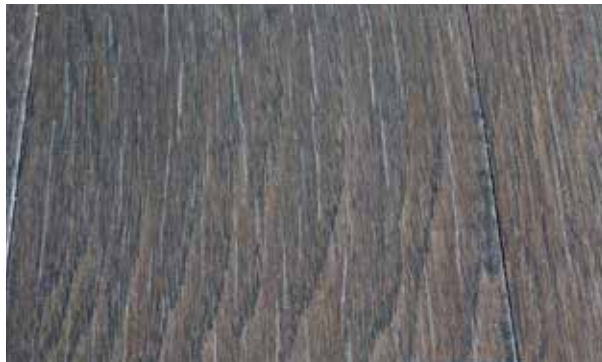
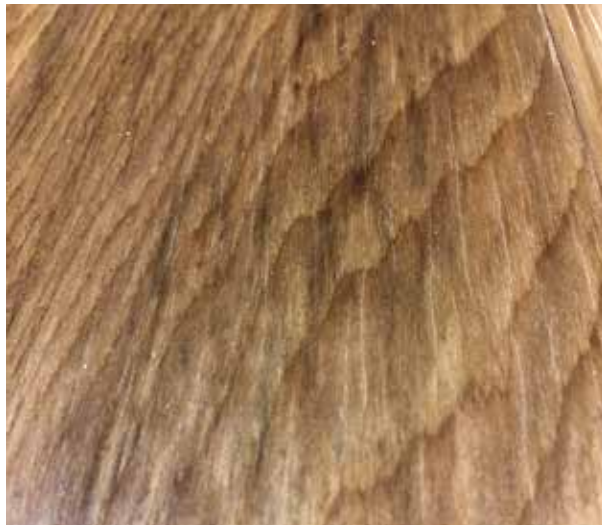
## Lathe Checks (Rotary Peeled or Sliced Engineered Flooring)

**DEFINITION:** In engineered flooring with rotary peeled or sliced face veneers, as the knife separates the veneer from the log, the separated sheet of wood is laid flat where stresses can occur in the region near the knife edge. If the strength of the wood is exceeded, this stress is relieved by separations (or checks) of the wood fibers parallel to the grain of the veneer at the knife edge. The knife edge of the veneer is known as the open (or loose) side, and the opposite side of the veneer is known as the closed (or tight) side. Lathe checks are not normally visible on the face of the finished board.

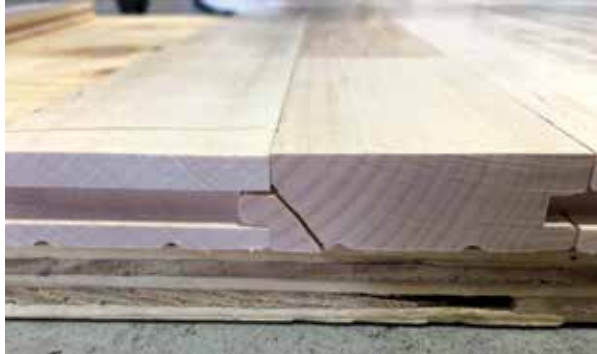
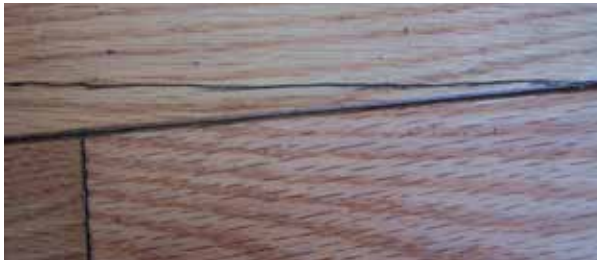
## Splits/Cracks

**DEFINITION:** A tearing apart or rupturing of the wood that may run at various angles to the growth rings.

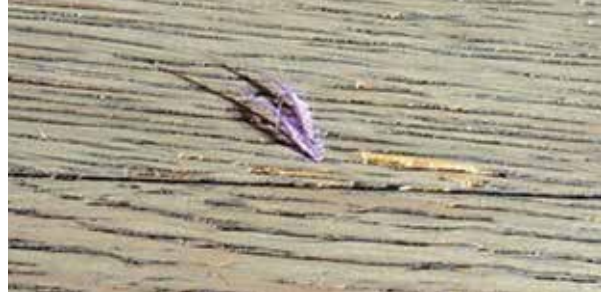
## Slivers/Splinters

**DEFINITION:** Sharp fragment of wood separated/fractured away from the edge or face of the board protruding from the floor.

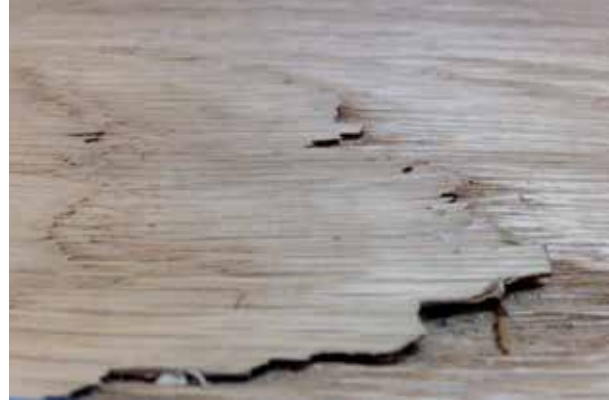
## Shake (Ring Shake/Ruptured Grain)

**DEFINITION:** A separation of the wood's fibers along the grain (parallel to the growth rings), that usually occurs between the rings of annual growth.

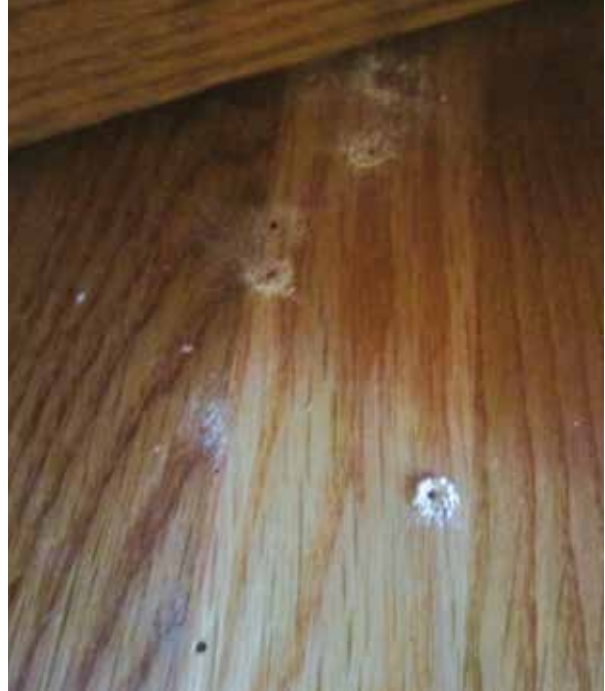
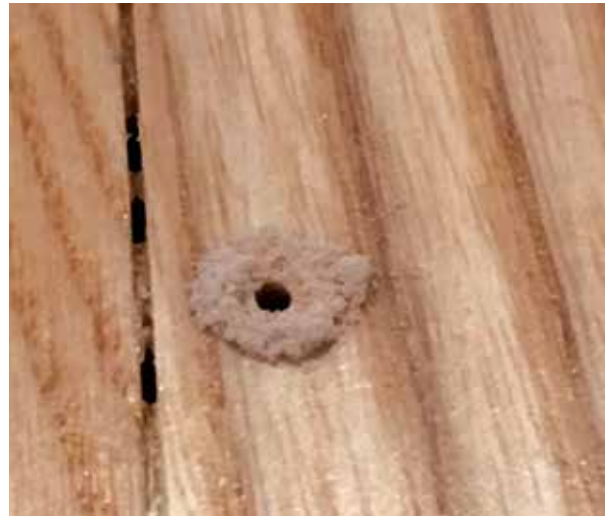
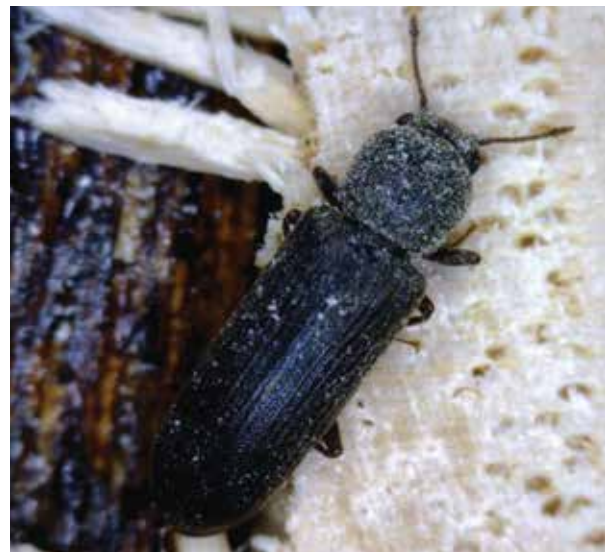
- Infestation often occurs long before, but can even occur after the wood floor is installed. Female beetles lay their eggs within the pores of the bare, unfinished wood. The larvae feed on the wood, creating tunnels that fill with a powdery substance called frass. Later, when the larvae mature, they exit the wood, creating small pinholes, generally measuring 1mm-3mm (1/16"). In active infestations, the holes will be surrounded by this frass (light-colored powder). This frass material is very fine and will feel like talcum powder when rubbed between two fingers. The presence of an actual beetle, beetle larvae, or frass is the only way to absolutely confirm an active infestation.

- **Termites** - Termites are attracted to areas where moisture accumulates in and around your home, including damp basements, laundry rooms, bathrooms, and leaky foundation walls.
  - Termites will eat any kind of wood including mulch, rotting wood, new wood, painted wood, and treated wood.
  - Stagnant, moist air in the home provides the perfect breeding ground for termites.
  - Termite-damaged wood is usually hollowed out along the grain, with bits of dried mud or soil lining the feeding galleries. Wood damaged by moisture or other types of insects will not have this appearance.
  - Termite infestations are a site-specific condition.

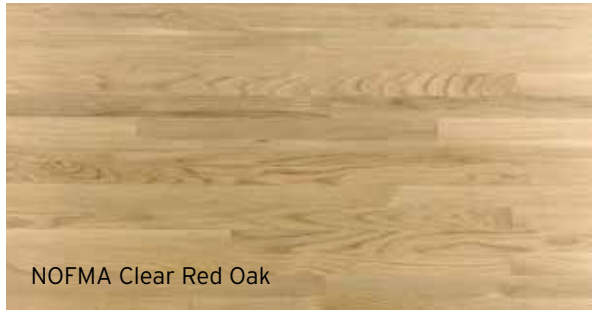
NOFMA Clear Red Oak

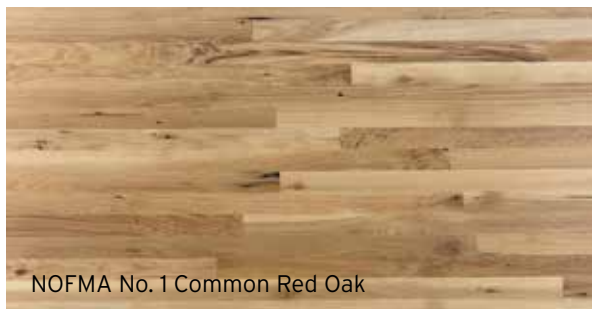
NOFMA No. 1 Common Red Oak

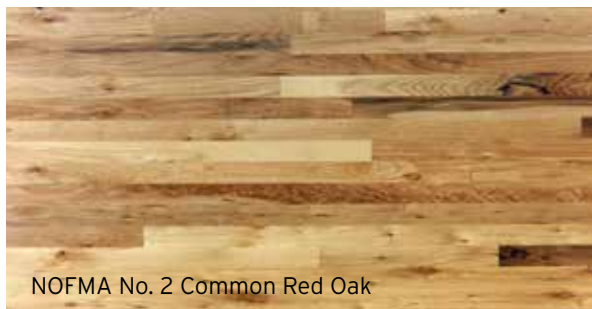
NOFMA No. 2 Common Red Oak

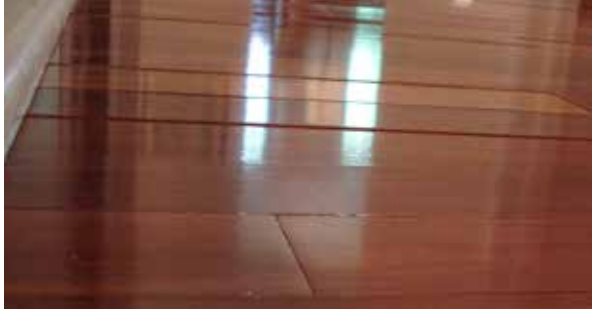
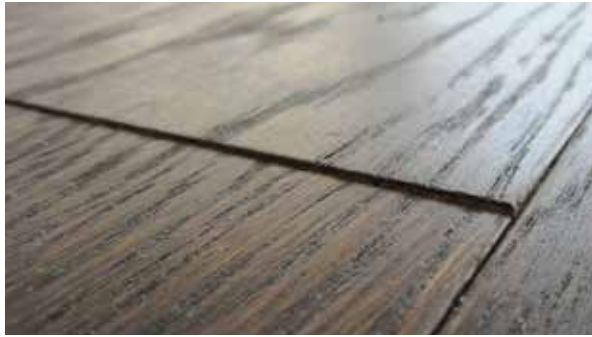
## Overwood/Underwood

**DEFINITION:** A vertical offset that exists between two adjoining installed floorboards.

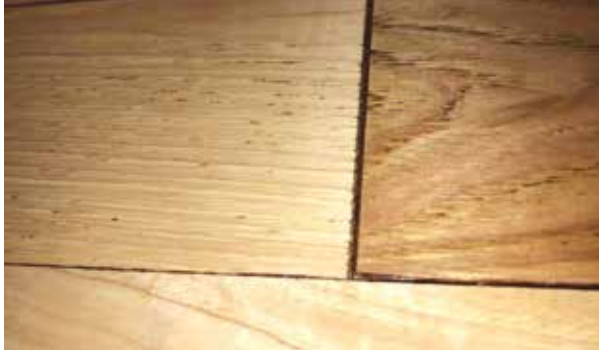
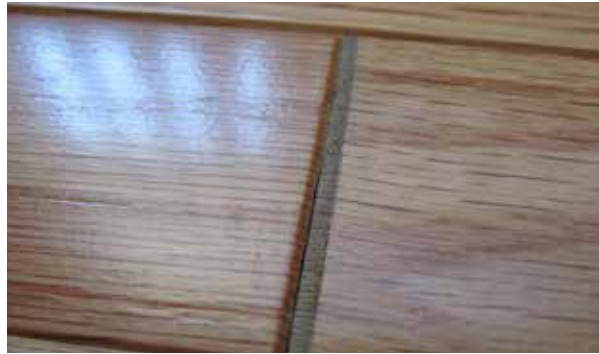
## Uneven Bevels

**DEFINITION:** Bevels within an installed or uninstalled wood floor appear inconsistent in width, depth, shape, profile, or size.

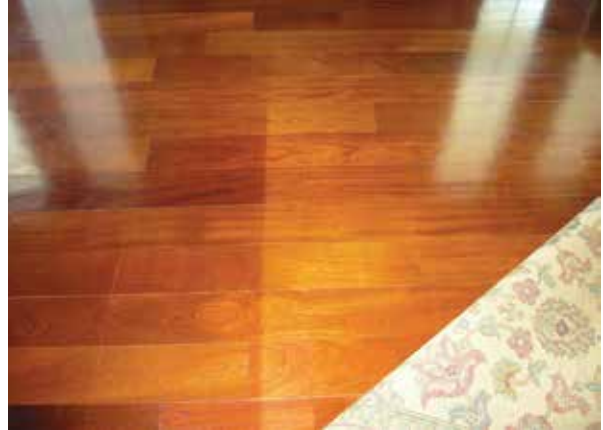
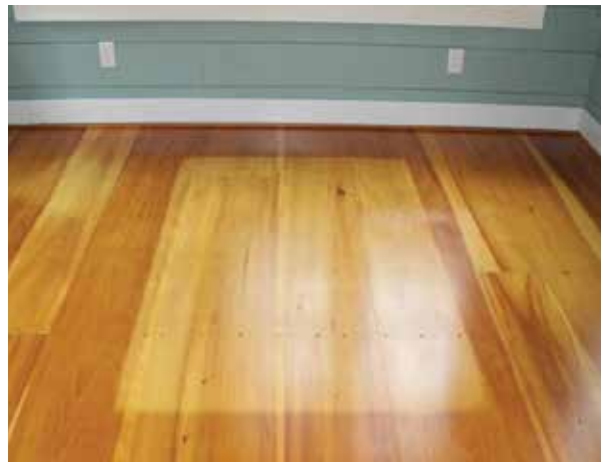
## Wood Discoloration

**DEFINITION:** The wood itself changes color over time (darkens or lightens).

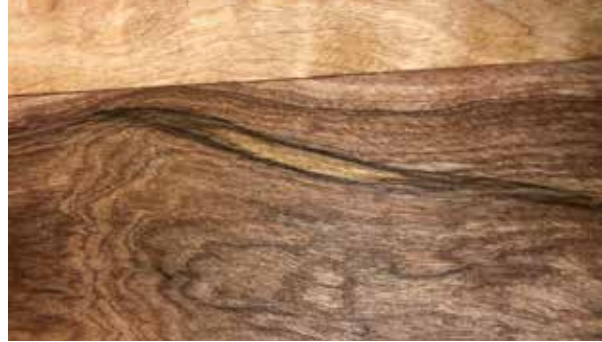
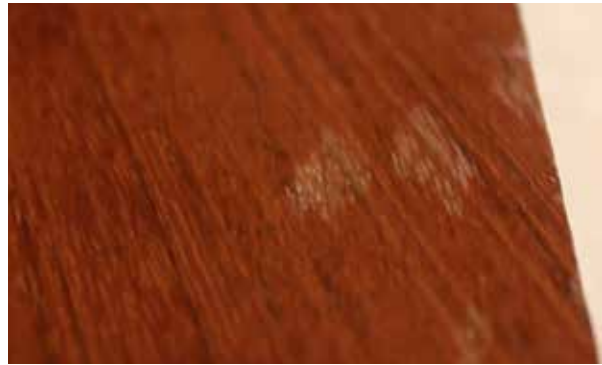
## Mineral Streaks/Deposits

**DEFINITION:** A discolored line, spot, or band in the wood that may range in color from light gray to tan, olive green, brown, purple, blue, or black. Mineral streaks/deposits are naturally occurring and they are often considered to add value and appeal to the wood.

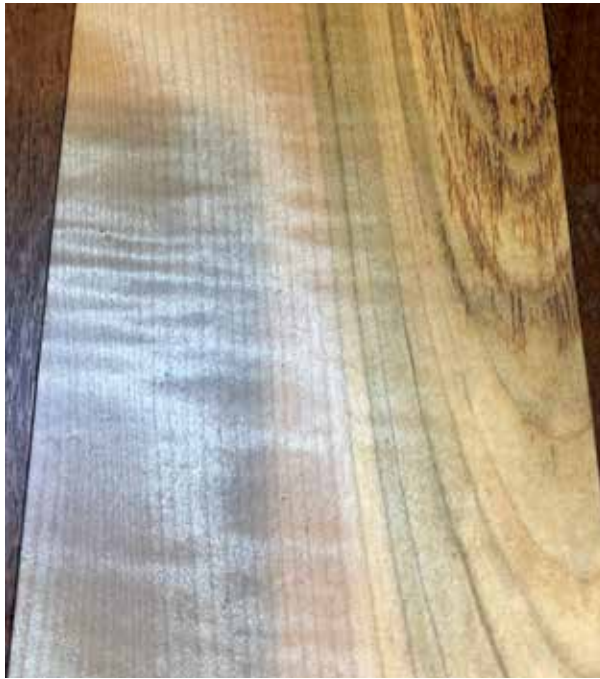
## Sap Stains (Blue-Stain or Brown-Stain)

**DEFINITION:** A discoloration in the sapwood. Sapwood itself is the active wood near the outside of the living tree. It is often lighter in color than the heartwood of the tree. Sapwood color variation is normal and acceptable in all grades, and must not be confused with sap stain.

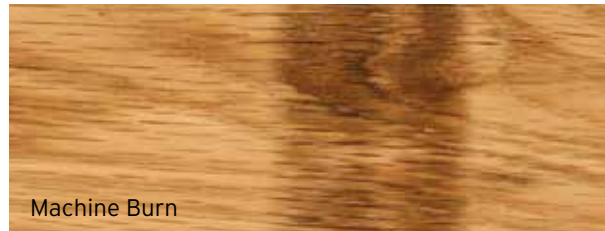
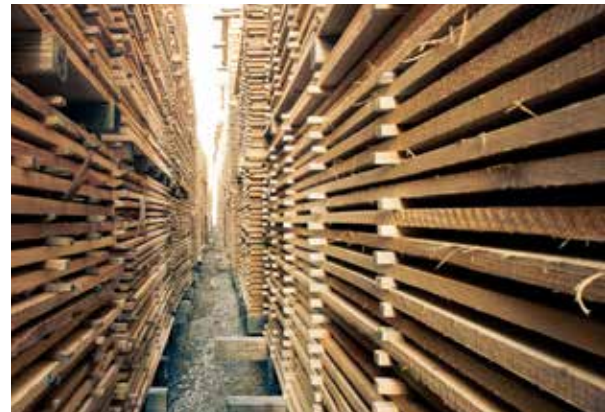
## Sticker Stains/Shadow

**DEFINITION:** A discoloration on the face of a board associated with the location of the stacker sticker. Sticker stain should not be confused with machine burn, which may look similar, but will often sand out.

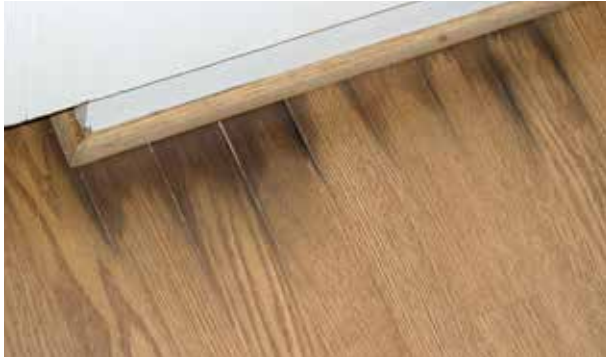
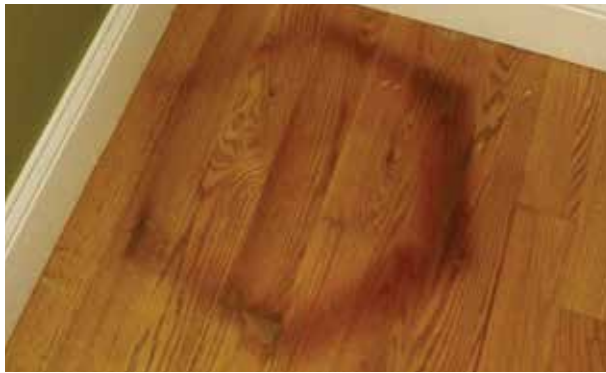
## Moisture Stains

**DEFINITION:** The wood or finish changes color with exposure to moisture.

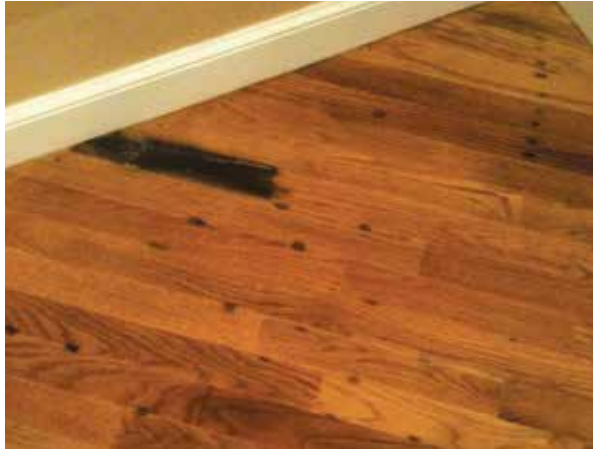
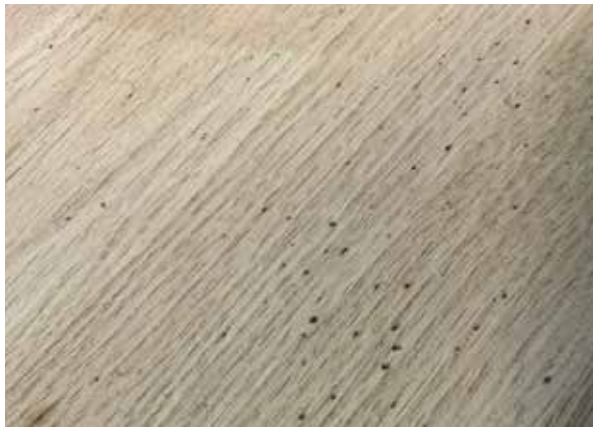
## Iron Stains

**DEFINITION:** A result of a chemical reaction between wood tannins, water, and iron.

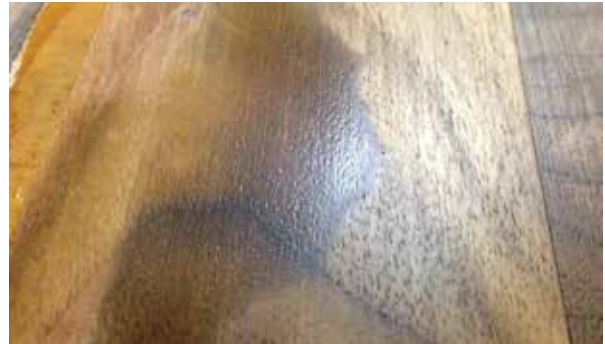
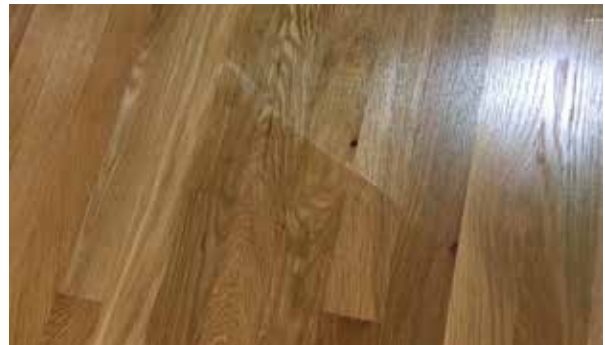
## Tannic Acid Discoloration/ Tannin-Pull

**DEFINITION:** Tannic acid includes various naturally occurring soluble astringent complex phenolic substances found in trees (and plants) as a way of protecting the tree from insects, fire, and bacteria. High levels of tannic acid present in woods like oak, walnut, and mahogany can produce a dark discoloration when coming in contact with some products used in the finishing and maintenance of wood floors.

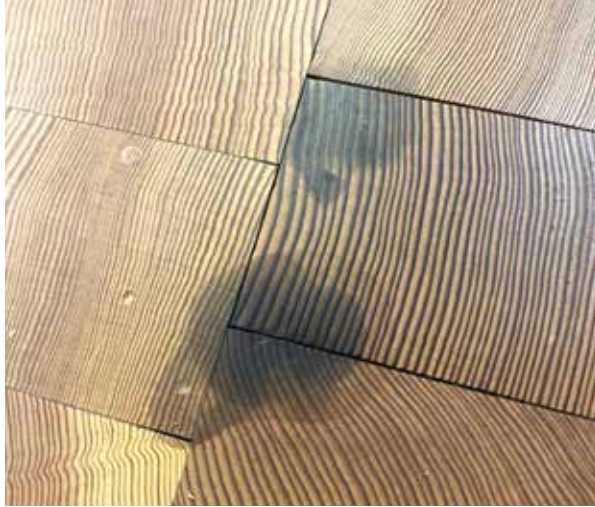
## Chemical Stains

**DEFINITION:** Irregular shaped spots or discolorations on areas of the finished floor caused by reactive chemicals and/or air pollution.

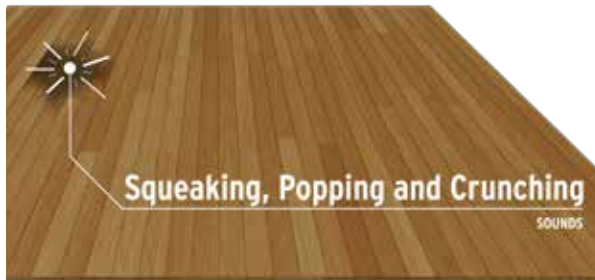
## Squeaking/Popping/ Crunching Sounds

**DEFINITION:** Audible squeaking, popping, or crunching noises in an installed wood floor or within the floor system. Squeaks are not a direct concern with the performance of an installed wood floor as long as movement accompanying the audible squeak does not affect the performance of the installation. An occasional squeak within any properly installed wood floor system is not abnormal.

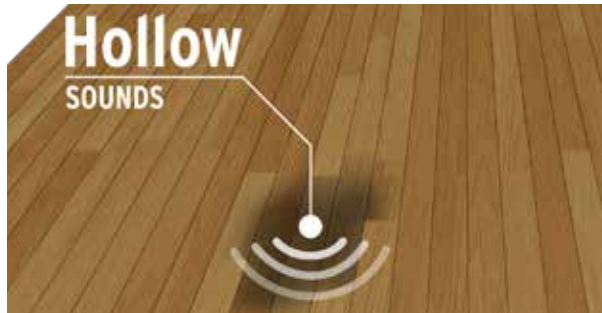
## Hollow Sounds

**DEFINITION:** An audible hollow sound in the installed wood flooring. When no deflection is present, this may be considered normal with many installation methods provided that the installation followed proper installation procedures. Hollow sounds are not a direct concern with the performance of an installed wood floor as long as there is not movement accompanying the audible hollow sound.

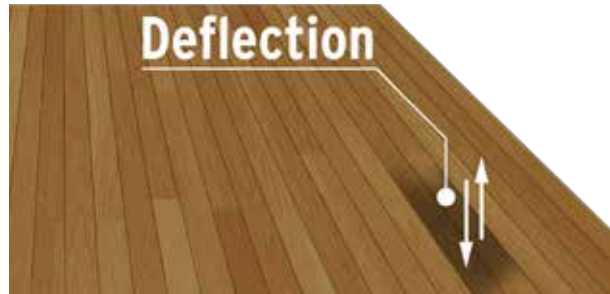
## Deflection

**DEFINITION:** Isolated areas in an installed floor system that exhibit vertical (up and down) movement when pressure is applied.

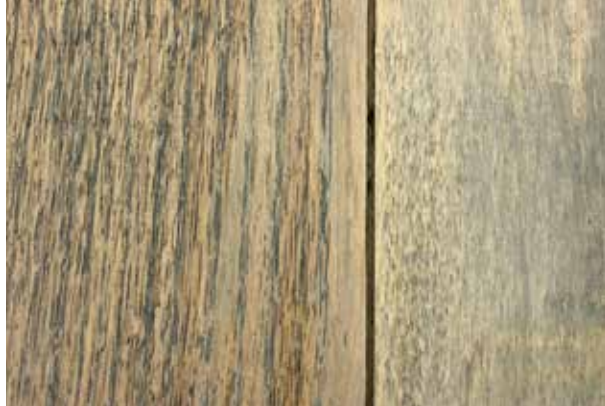
## Seasonal/Normal Gaps

**DEFINITION:** Gaps that appear between individual boards, opening and closing with seasonal humidity changes. Wider boards can experience wider gaps. Gap size is directly related and proportional to the board width.

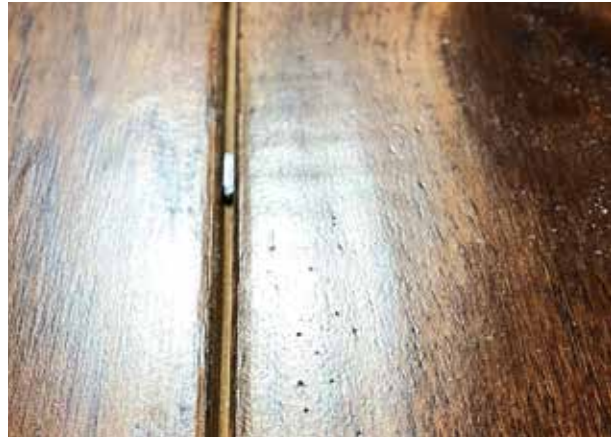
## Abnormal Gaps

**DEFINITION:** Gaps between abutting wood floor boards in the installed floor that were not intentionally placed and remain with seasonal fluctuations in moisture and humidity.

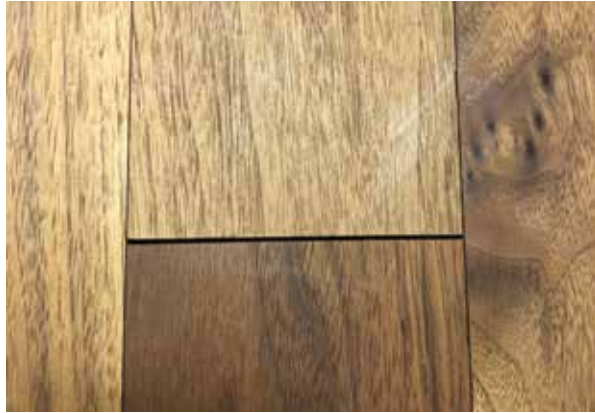
## End-Gaps

**DEFINITION:** A separation that occurs on the ends of two abutting wood floor boards.

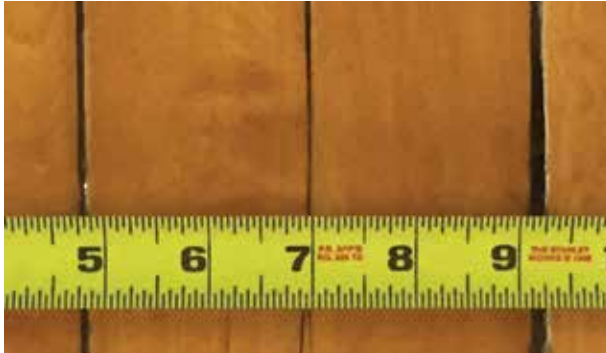
## Compression-Set

**DEFINITION:** A generally uniform appearance of gaps between wood floor boards that directly coincides with the narrowing/crushing of individual board edges as a result of permanent cellular damage. The appearance of a compression-set floor may be similar to gaps from other causes, such as flooring that was milled and installed with high moisture content. When they are at the same moisture content at which they were milled, compression-set boards will be narrower than the milled width and may exhibit slightly raised edges along the board edges.

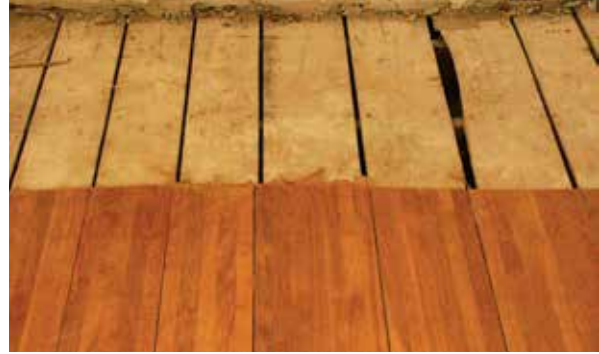
## Panelization

**DEFINITION:** A generally uniform appearance of gaps or peaks in the surfaces of the wood floor that directly coincide with movement in the subfloor material beneath it.

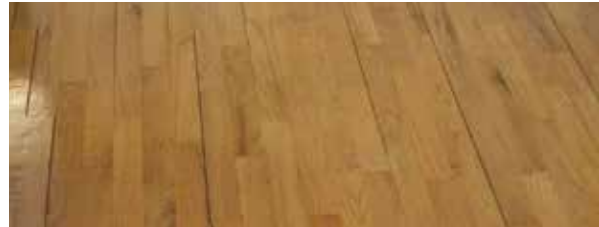
**Sidebonding**

**DEFINITION:** A condition where localized gaps develop between flooring boards while adjacent groupings of boards remain tightly bonded together with no apparent separations. These gaps will sometimes exhibit wood fractures along the gap as a result of the finish bond tearing away small pieces of wood from the adjoining plank. Sidebonding should not be confused with panelization. (See Panelization.)

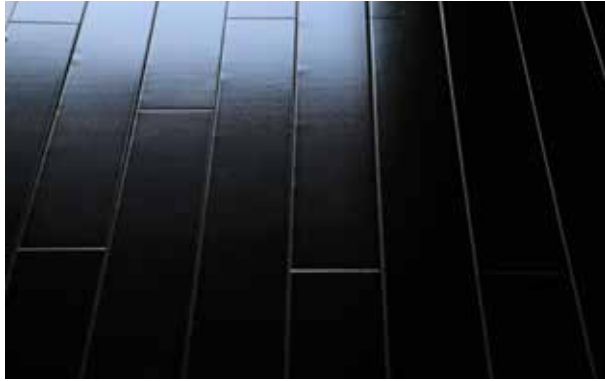
## Telegraphing Fastener/Dimpling

**DEFINITION:** Dimples or bumps along the nailing surface of the finished flooring, directly related to fastener location and/or installation method.

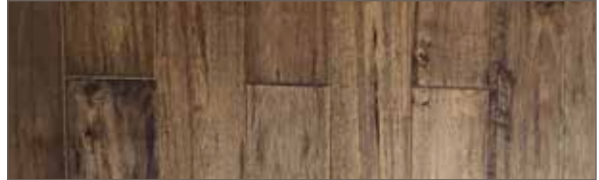
With solid or engineered wood flooring installed over concrete or a wood panel subfloor and joist systems that meet or exceed NWFA minimum requirements, properly staggered end joints are an appearance/aesthetic consideration.

With 3/4" and greater strip or plank wood flooring installed over bare joists, solid board subfloors (1"x6"), "perpendicular car decking," sleepers/screeds, other non-continuous subfloor systems, or panel-type subfloors that do not meet NWFA minimum requirements, the layout of the entire floor, and end joint placement, are not only an appearance/aesthetic consideration, but also add a structural element to the finished installation. Stair-stepped and clustered end joints may reduce the ability of the flooring system to withstand the additional stresses created in these circumstances.

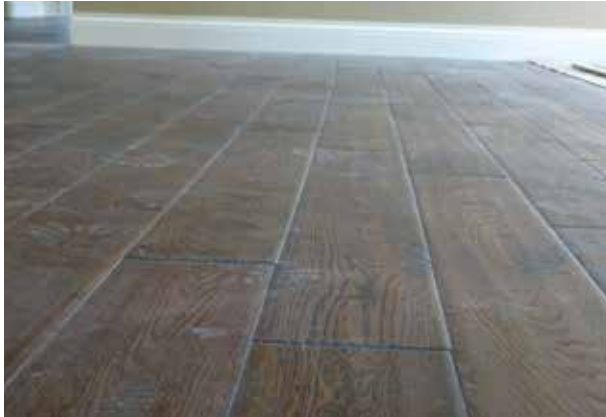
## Crooked Installation Discrepancies

**DEFINITION:** An installed wood floor appearing bowed or out-of-square within the room in which it is installed. No wood floor installation is perfectly straight, parallel, or perpendicular to walls or fixtures. When the straightness of the installed floor takes away from the overall appearance of the floor within the structure, an aesthetic remedy may be necessary. The performance and structural integrity of the wood floor is not normally affected with any floor that has been installed out-of-square or out-of-a-straight-line.

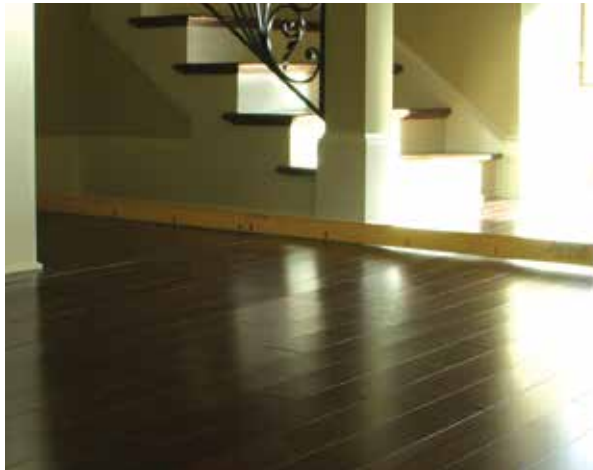
**DEFINITION:** The installed wood floor system appears to be uneven, wavy, or out of flat. Wood floors may be installed over out-of-level subfloors, but should fall within NWFA floor flatness tolerances. Subfloor flatness cannot be quantifiably measured when a floor covering is in place over it (without potentially extensive destructive testing), however, may give a good indication of what is happening below.

It is the responsibility of the flooring installer to assess substrate flatness, moisture requirements, and panel thickness/joist span combinations prior to installation. Reference NWFA Wood Flooring Installation Guidelines, and the flooring manufacturer installation instructions, for applicable tolerances. Gradual variations in subfloor flatness may not affect the performance of the installed wood floor, but may be considered unacceptable when overwood, vertical movement, slight gapping, squeaking, or noisy floors are present.

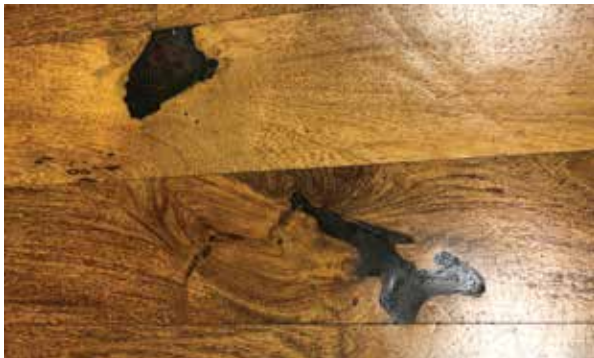
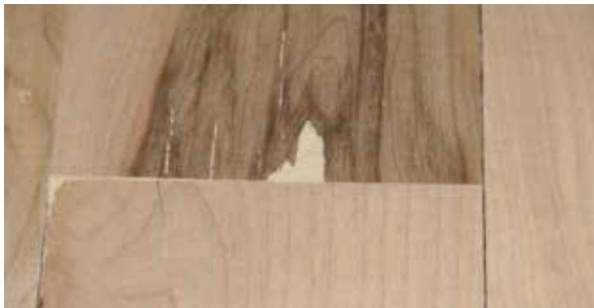
## Filler Color Variation

**DEFINITION:** The wood filler from one area of the floor is different from the overall color tone of the floor. No two trees from the same species are identical, no two boards from the same tree are identical, and color and grain patterns can vary even within one individual plank of wood. Wood filler will never perfectly match, nor is it designed to match every board within a wood floor.

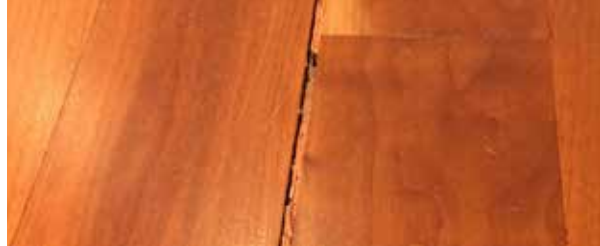
## Popped Filler

**DEFINITION:** Wood floor filler that has become loose or no longer fills the void it was once in.

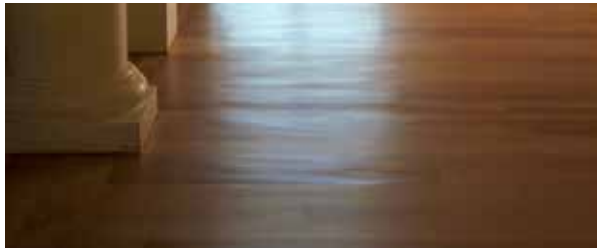
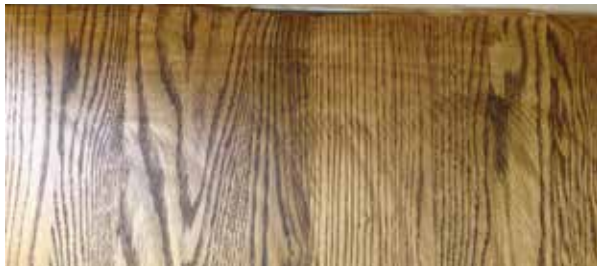
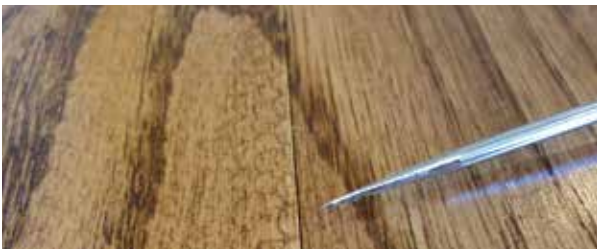
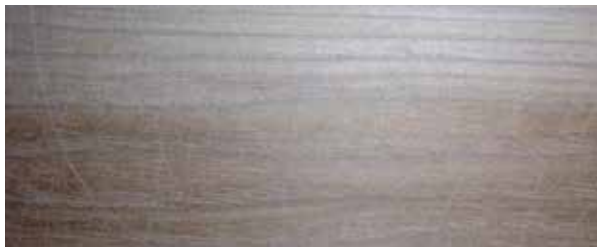
## Sanding Marks

**DEFINITION:** Sanding imperfections seen as drum marks, side cuts, sanding scratches, or swirl marks. Sanding marks should be viewed from a standing position on the floor being assessed, in ambient lighting conditions. Glare from a direct light source must not be used during evaluation. Inspection may take place from floor level and/or with assistance of magnification in order to determine causes of irregularities, but not to determine acceptability.

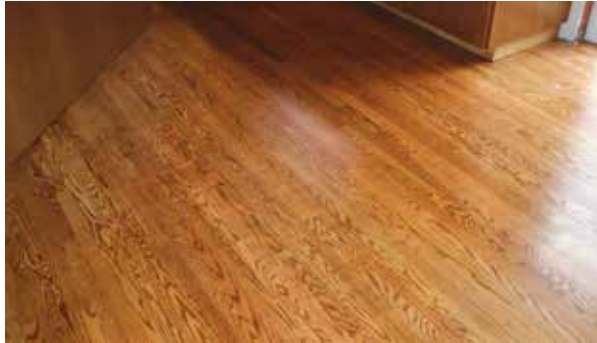
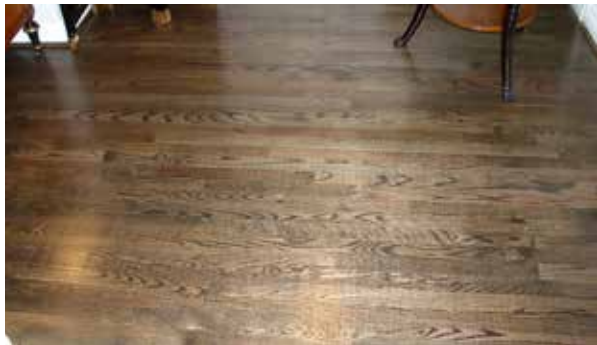
## Chatter

**DEFINITION:** Slight unintentional indentations causing a ripple-like wave effects or “bars” that run perpendicular to the wood’s grain direction on the surface of a wood floor which can become visibly pronounced in direct lighting. The width of these “bars” can range from just a few millimeters to nearly an inch from peak to peak, and can occur in limited regions or can span the entire floor.

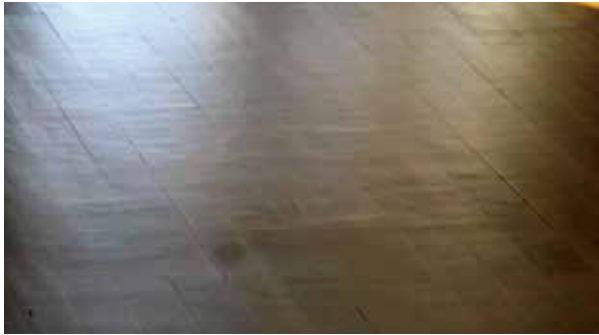
## Wave

**DEFINITION:** Indentations, usually repeating undulations, visible on a site-sanded wood floor surface, most often visible after a finish has been applied. The width of these irregularities typically range from one inch to three inches or more, and can occur in limited regions or can span the entire floor. Wave can sometimes be in conjunction with, or confused with, dishout.

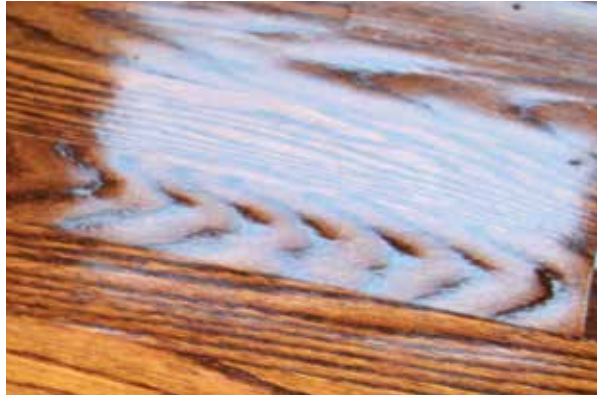
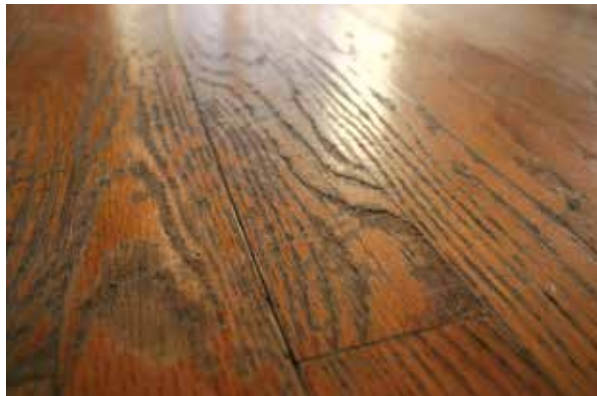
## Dishout/Shellout

**DEFINITION:** Undulations in the surface of individual boards or within the wood floor, resulting from softer areas having been worn, hollowed, or sanded to a lower level than harder adjacent areas.

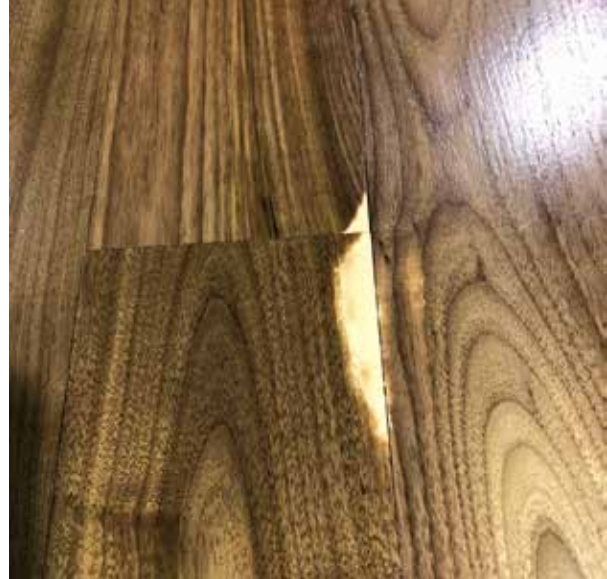
## Veneer Sand-Through

**DEFINITION:** The top/wear layer veneer (lamina) of engineered flooring has been completely sanded through to the core layer.

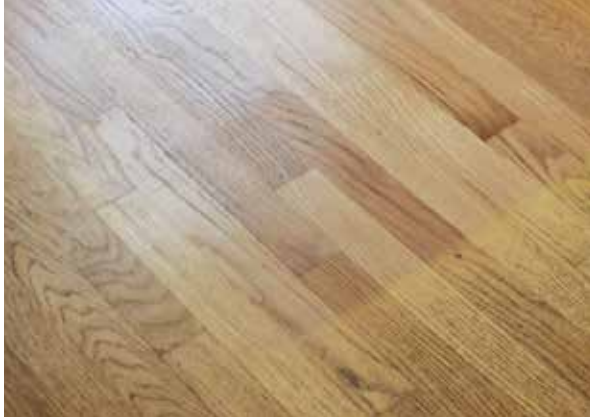
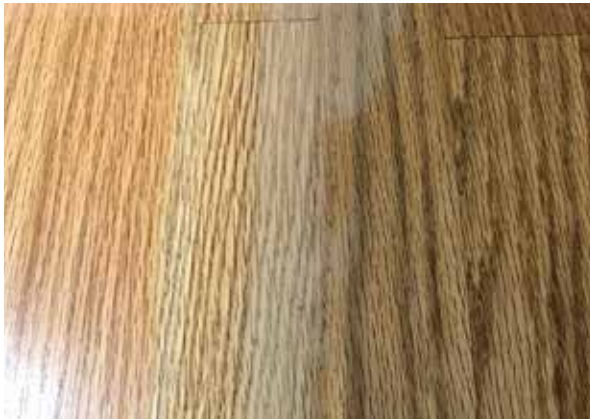
## Finish/Colorant Discoloration

**DEFINITION:** The finish or colorant systems changes color.

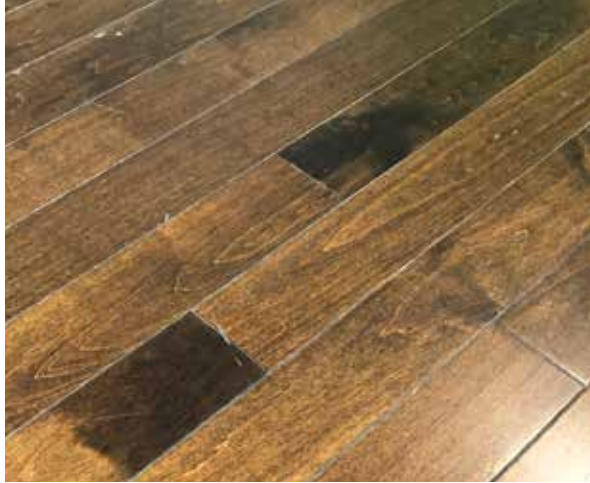
## Blotchy Stain/Colorant

**DEFINITION:** The appearance of an inconsistent stain or colorant from one area of a finished floor to another. Stained/colored floors should be uniform in color. Color tones may vary from board to board or within individual boards due to natural variances within the wood.

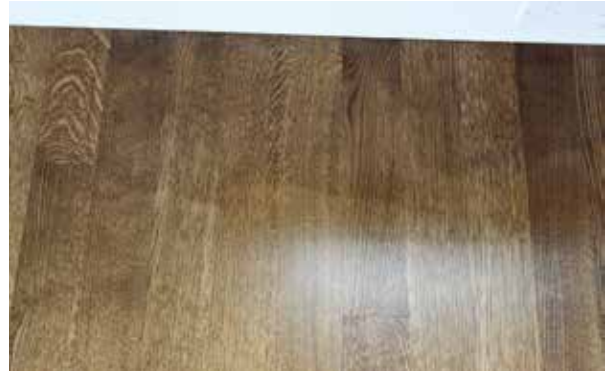
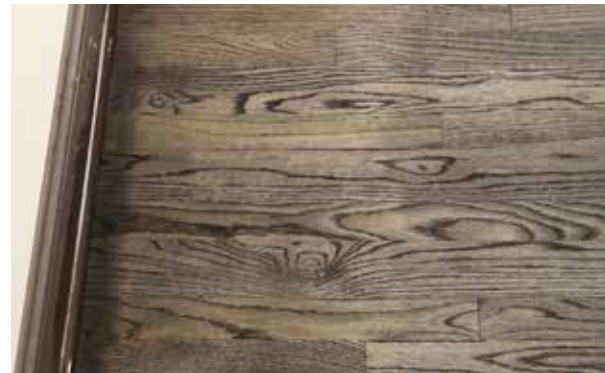
## Picture Framing/Halo

**DEFINITION:** The edges of the room appear to be a slightly different color than the rest of the room.

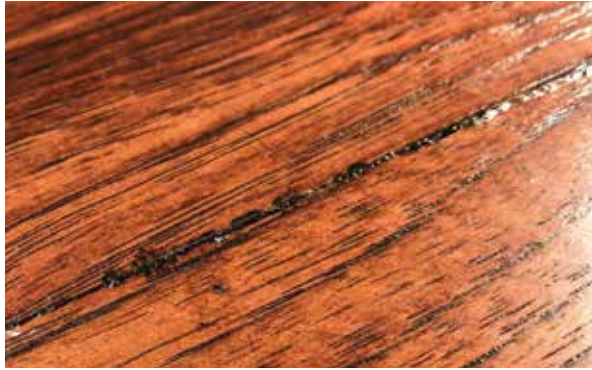
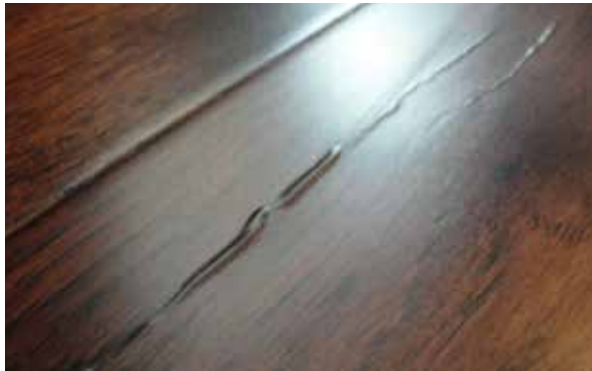
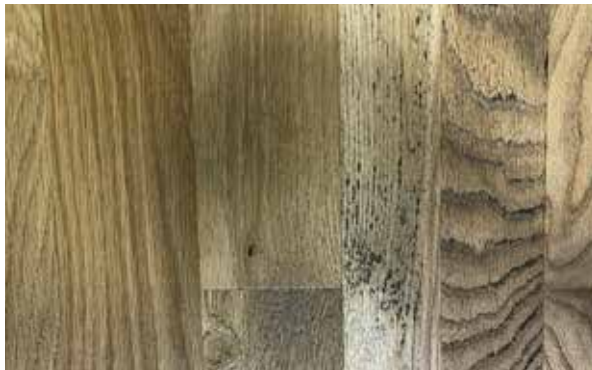
## Stain Bleed Back

**DEFINITION:** A staining phenomenon occurring after the initial application of the stain, where the stain seeps back to the surface of the wood. This may happen at board seams, with open-grain species, tight grain, knots, or burls.
