# PROBLEMS, CAUSES, AND CURES

This technical publication was developed by subject matter experts serving on the Problems, Causes, and Cures Taskforce, and on the NWFA Technical Standards and Publications Committee, using reliable principles, with research of all available wood flooring data, and in consultation with leading industry authorities.

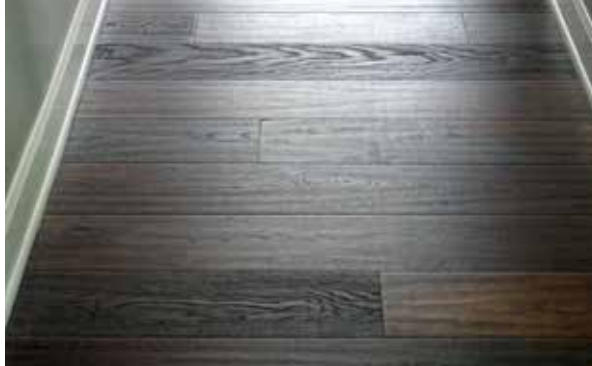
## Finish Film-Thickness Discrepancy

**DEFINITION:** A discrepancy in the depth of the film of finish applied to a wood floor. Mil/film thickness of finish can be evaluated, but should not determine acceptability.

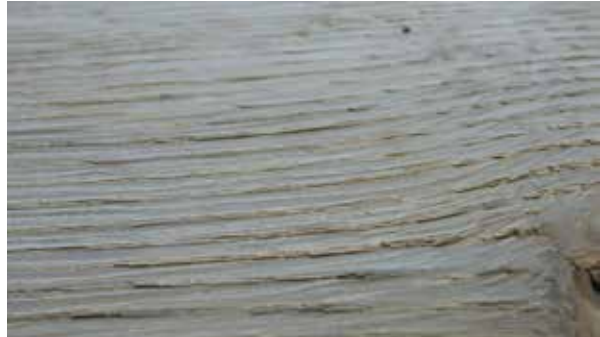
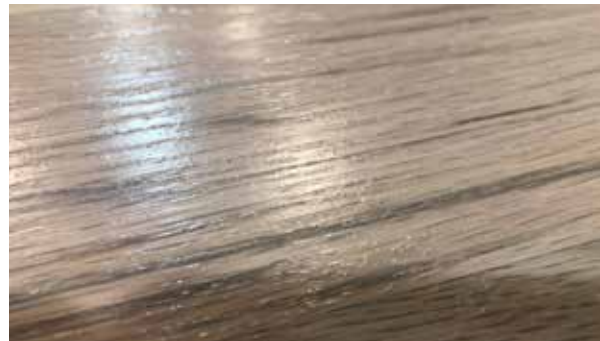
## Roughness/Grain-Raise

**DEFINITION:** The surface of the wood floor feels rough to the touch.

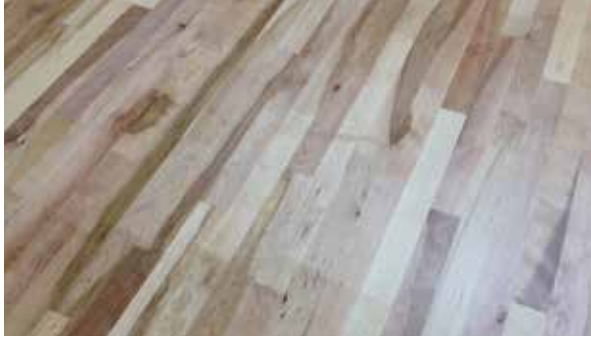
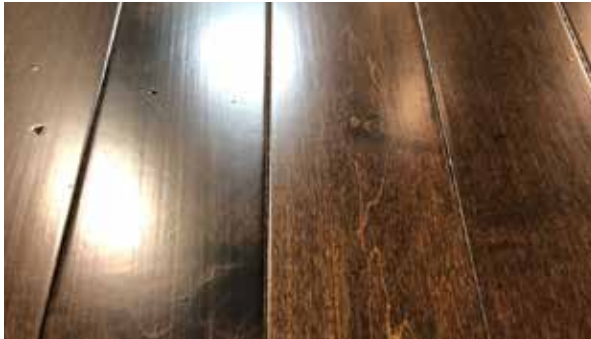
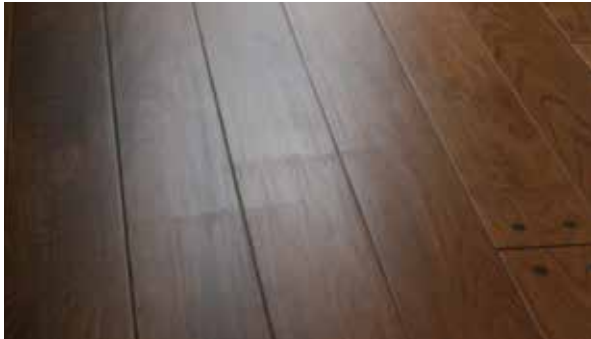
## Applicator/Finish Streaks

**DEFINITION:** Visible ridges, lines, or marks left on the wood floor, representing the application tool used from any stage of the finishing process.

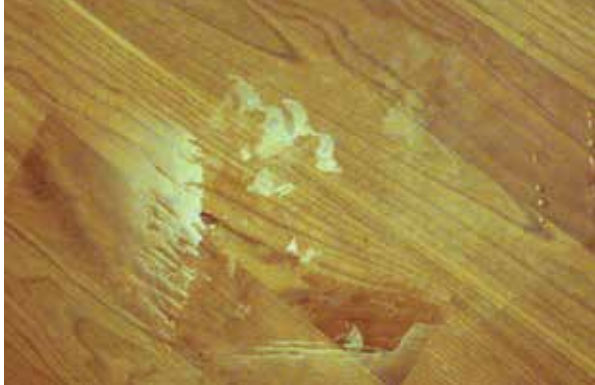
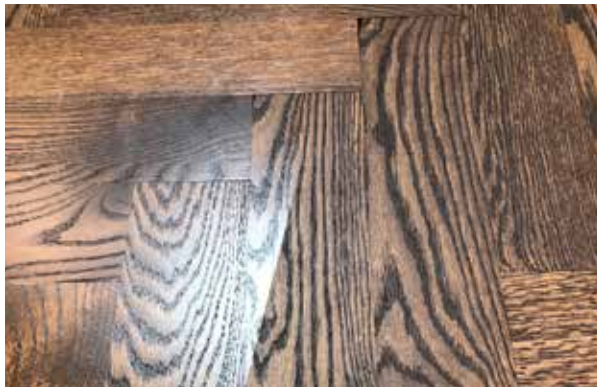
## Holidays/Skips

**DEFINITION:** An exposed area of uncoated wood or the undercoating, when the intention was to coat the entire area.

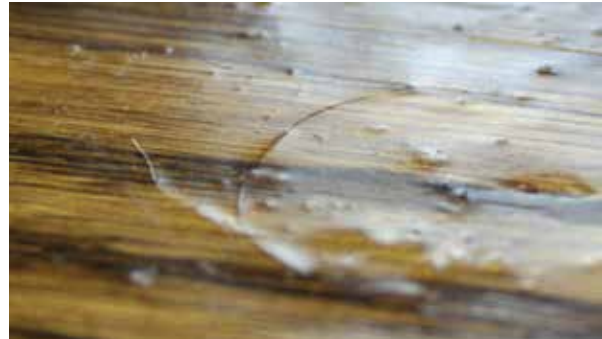
## Debris in Finish

**DEFINITION:** A raised bump in the film of finish often consisting of dust, hair, applicator fibers, foreign contaminants, solid finish particles, or other artifacts. Due to the nature of most coating environments, minimal amounts of debris within reason can be expected in any coat of finish.

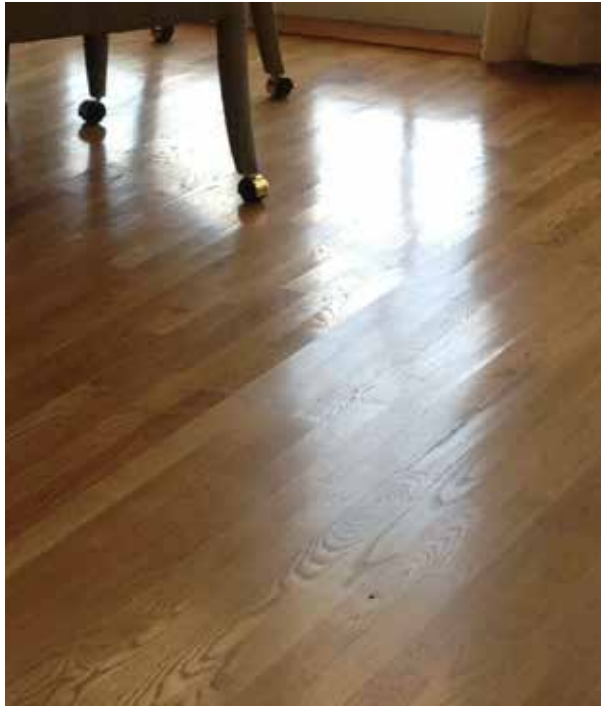
## Uneven Sheen/Gloss Levels

**DEFINITION:** The sheen or gloss level of the final coat of finish varies from one area of the floor to another. As film-forming finish products decrease in gloss, they increase in amounts of matting agents. Lower sheen products have the most matting agent, and thus, can more-easily manifest uneven sheen levels. Sheen/gloss levels should not be assessed until all final coats have been applied and are fully cured.

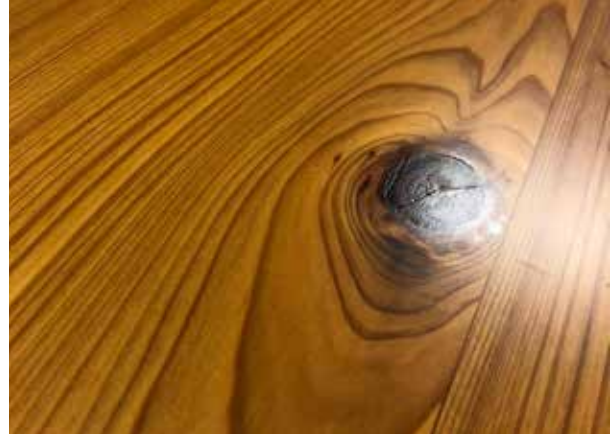
**Sticky Board Syndrome**

**DEFINITION:** Wood floor finishes that do not dry, adhere, cure properly, or appear the same on specific areas of a board or individual boards.

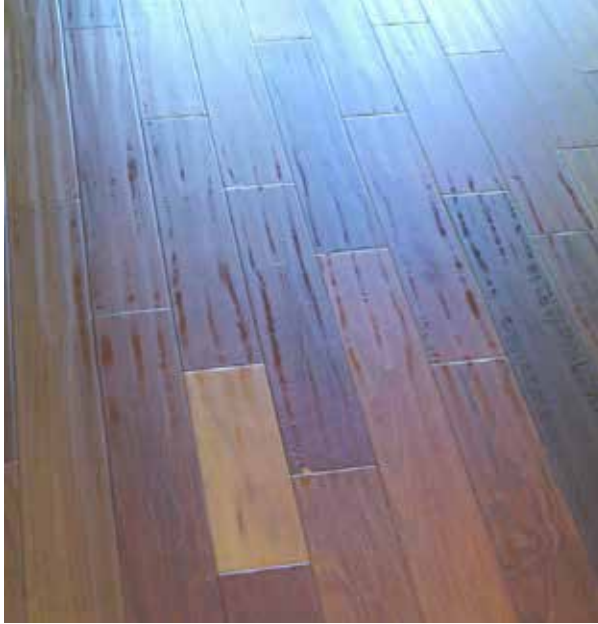
## Cloudy Finish

**DEFINITION:** An unintended white, milky, or cloudy appearance of an otherwise transparent, clear finish.

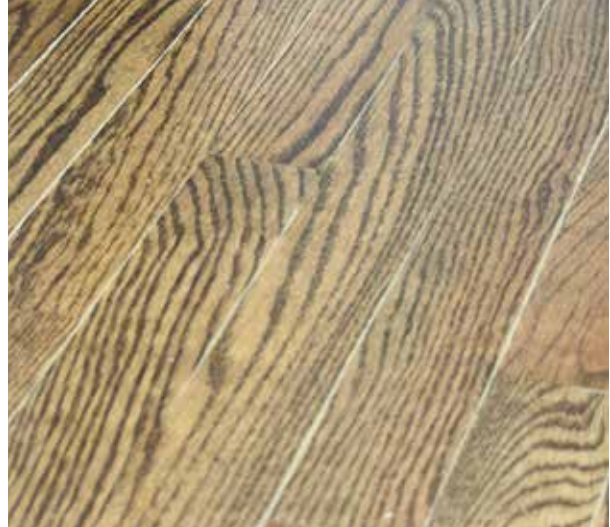
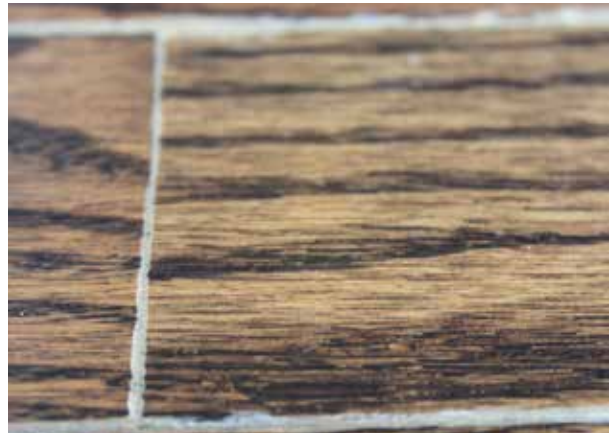
## White Lines

**DEFINITION:** White lines appear between board edges of site-applied film-finishes.

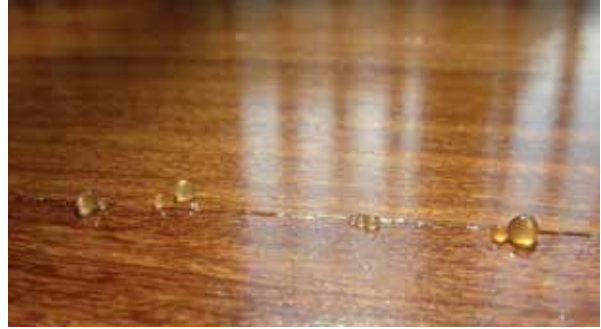
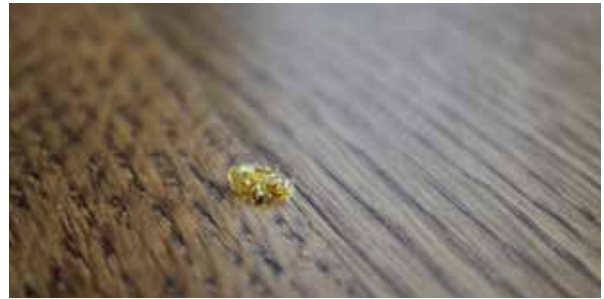
## Poly Beads

**DEFINITION:** Small round balls that appear as beads, or “BBs” of finish, that form along the joints of the individual boards. They can be soft and sticky when first formed, and will become hard if left undisturbed. When these wet beads are stepped on, they can become unsightly smears along board edges.

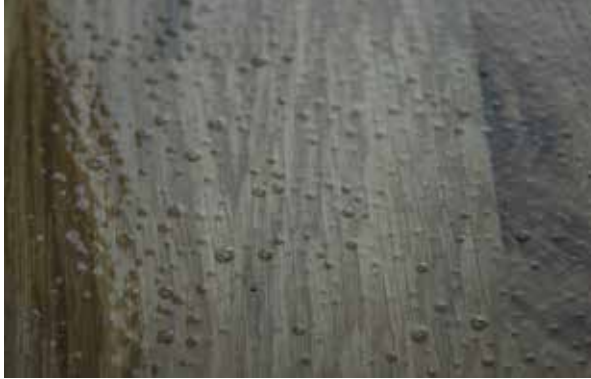
## Bubbles

**DEFINITION:** Raised bumps, or air-filled bubbles visible in the film of the finish. These include both full bubbles and bubbles that have popped.

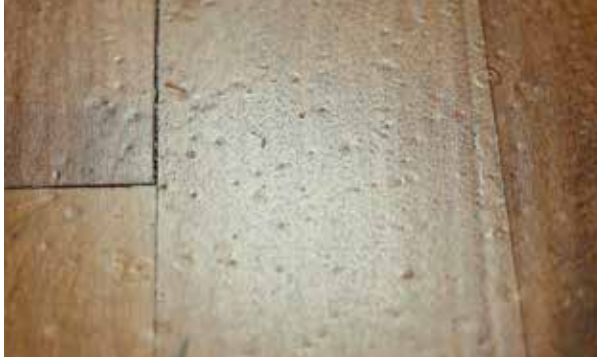
## Pin Holes

**DEFINITION:** A visible finish imperfection where the surface of the finish film recedes from a very small area or areas of the surface.

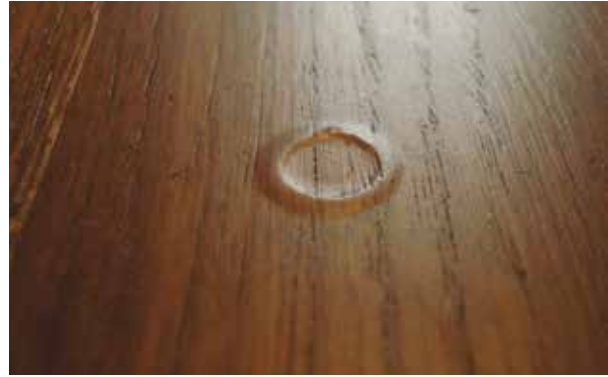
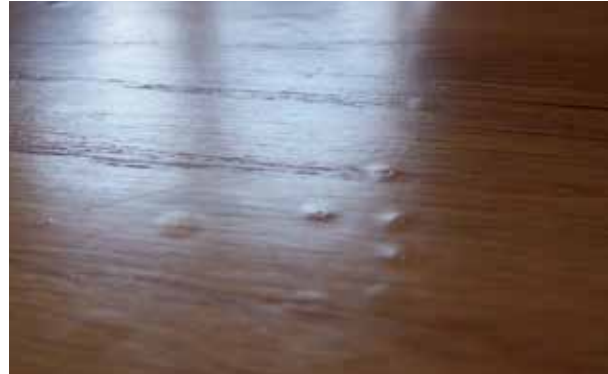
## Craters/Fisheyes

**DEFINITION:** A visible finish imperfection that manifests by the crawling of wet finish film into a single area or pattern resembling small dimples or bowl-shaped depressions, sometimes accompanied by a particle in the center.

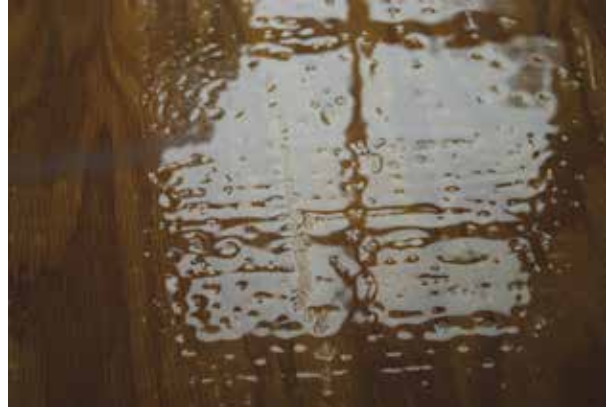
## Crawling

**DEFINITION:** A visible finish imperfection where the finish film is repelled from areas of the surface, leaving the appearance of thin or uncoated affected areas. May be very long and oval shaped, and may vary in size.

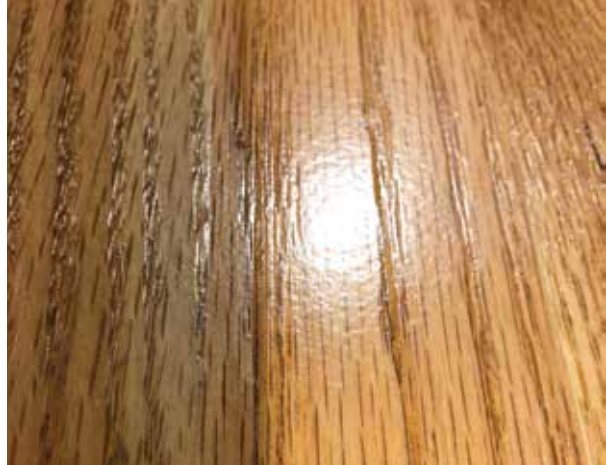
## Orange Peel

**DEFINITION:** A visible finish imperfection where the surface of the dry finish film exhibits a flaw that resembles the texture of an orange peel.

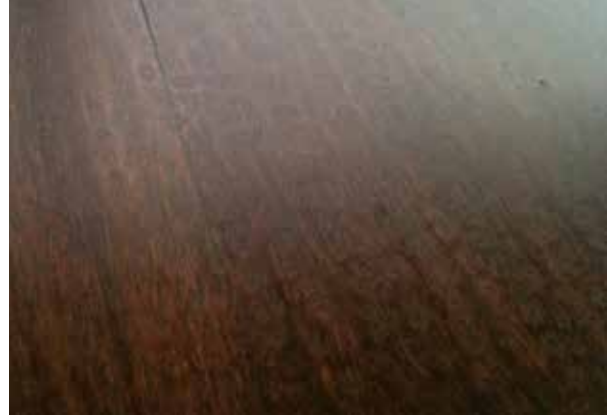
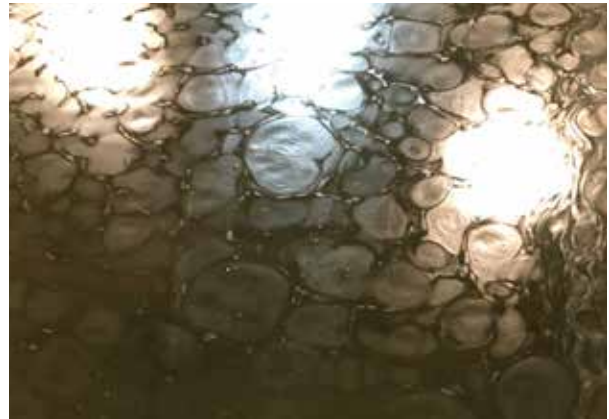
**Benard Cells**

**DEFINITION:** A visible finish imperfection resembling a pattern in the smooth finish film that resembles a clustering of "cells." They typically appear as less-glossy, often round, curvy, or geometrical (hexagonal, pentagonal) in shape, and may range in size from very small, up to 1". Benard cells are more common with lower sheen or pigmented finishes.

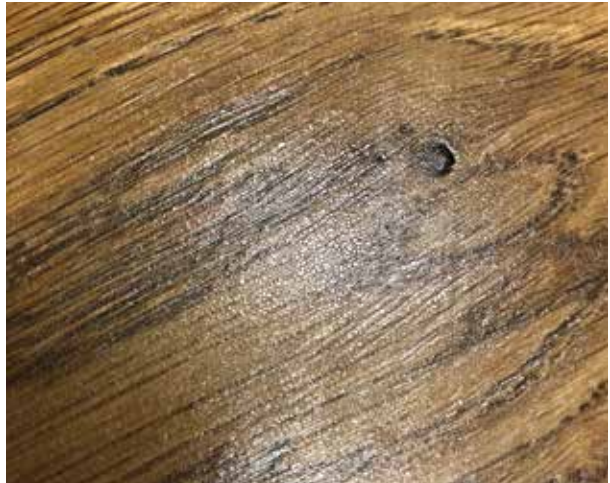
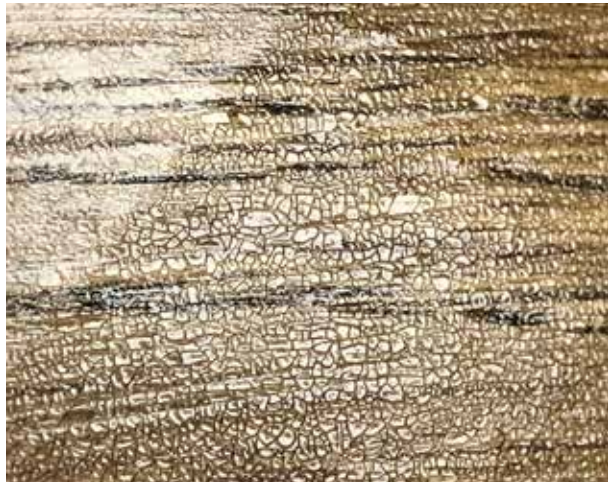
## Crazing/Alligatoring

**DEFINITION:** A visible finish imperfection that appears as a network of very small, fine cracks or fissures in the surface of the finish film, which sometimes resembles the skin of an alligator or crocodile.

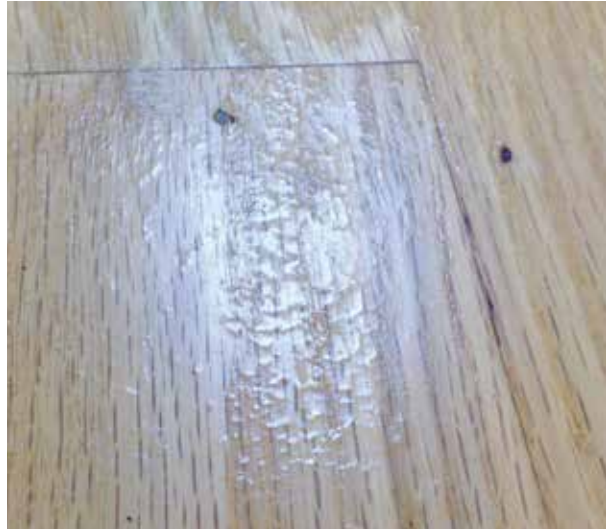
**Wrinkling**

**DEFINITION:** A visible film-finish imperfection that appears as the skin of a dried prune. Wrinkling may happen with all types of film-finish, but is most common with oil-based urethanes.

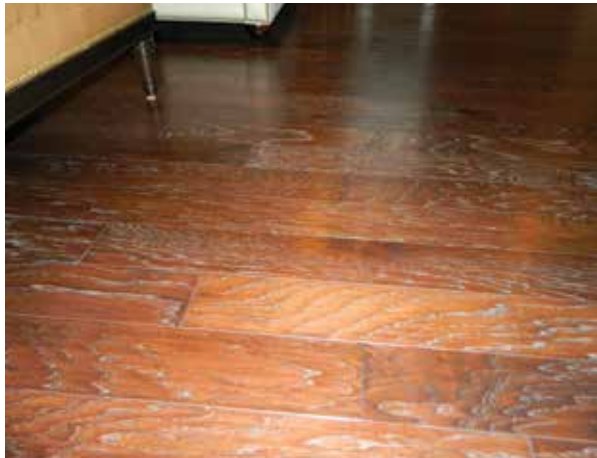
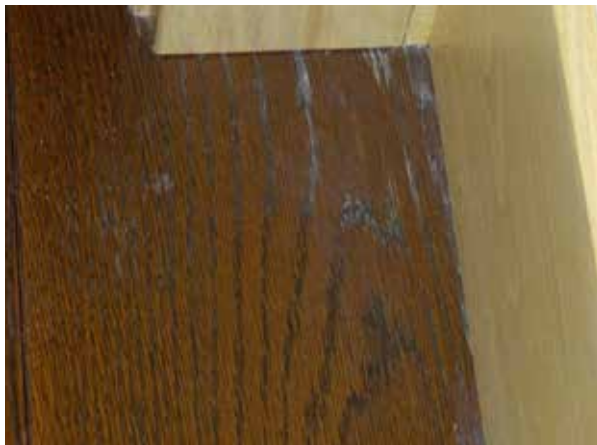
## Open-Grain Contamination

**DEFINITION:** An accumulation of contaminants in open voids or characters, such as in textured wood, the soft grain/springwood, open knots, splits/checks, etc., on the surface of the installed floor.

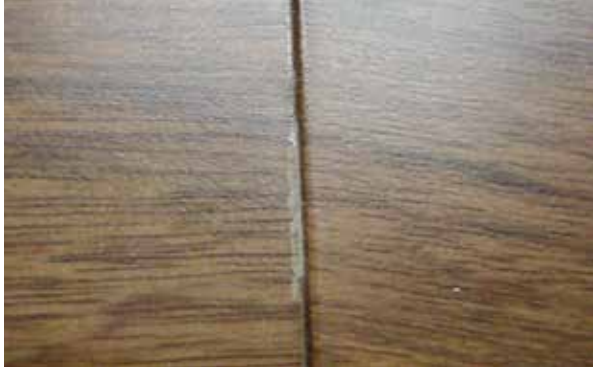
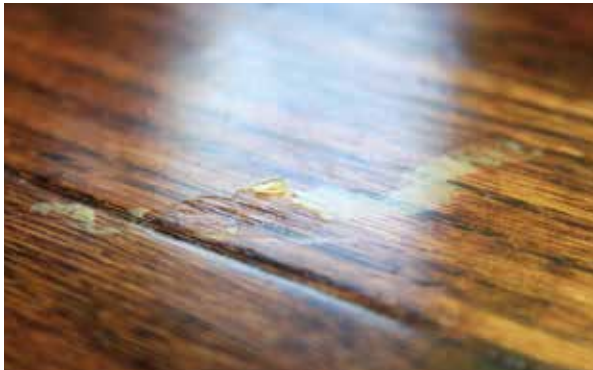
**Chipping/Flaking Finish** - The condition that occurs when a dried film of finish separates from the previously applied finish in the form of chips or flakes.

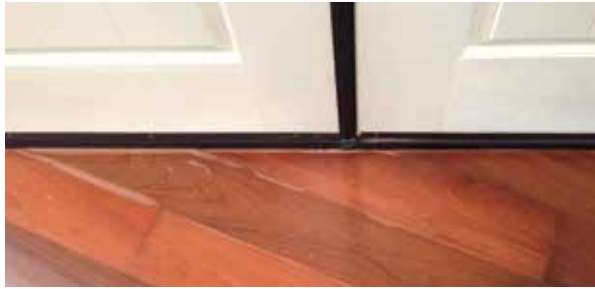
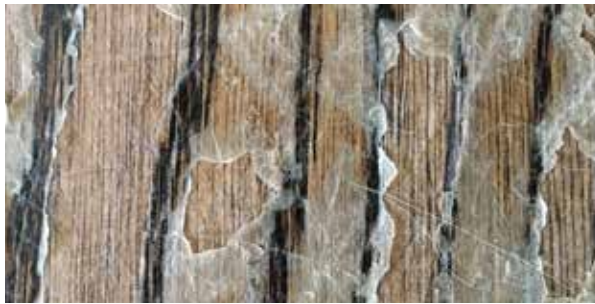
**Peeling Finish** - The condition that occurs when a dried film of finish separates from the underneath surface in the form of large pieces or sheets.

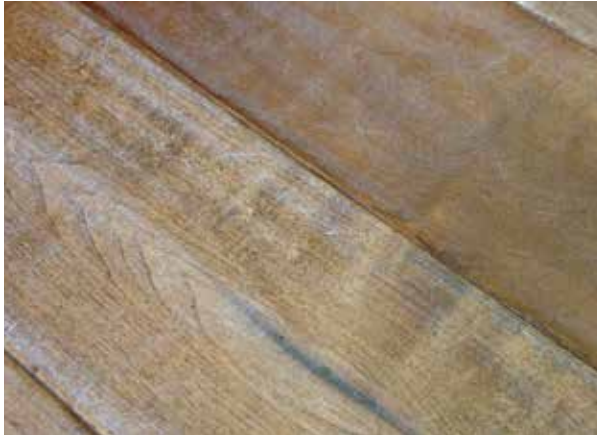
## Finish Wear Discrepancies

**DEFINITION:** The performance of the surface coat of finish not meeting expectations.

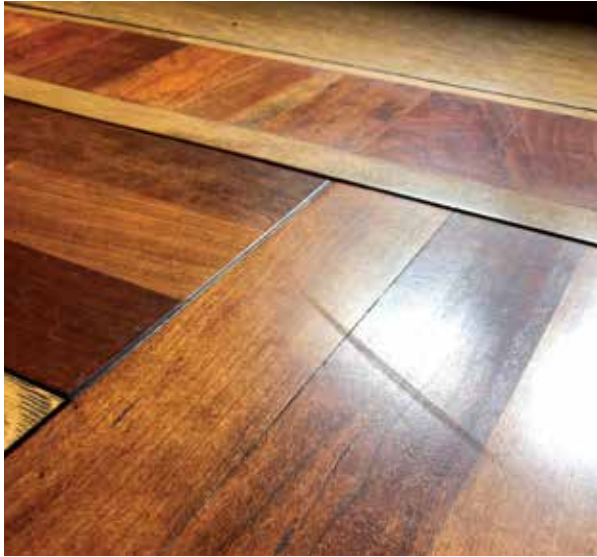
## Scuffing

**DEFINITION:** Marks or abrasions left on a wood floor surface or finish.

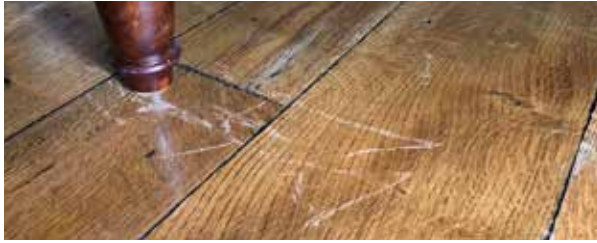
- **Scratches** - caused by applied horizontal and vertical forces.

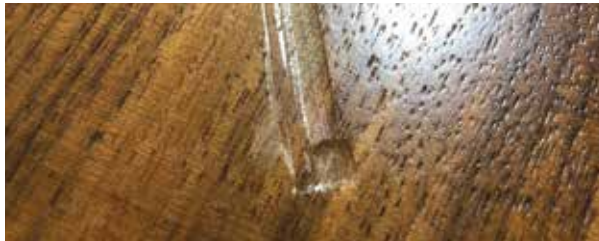
- Finish systems may be marred or scuffed, either from chemicals or from heat generated by sliding objects across them. These may look like scratches, but are not.
- Surface scratches are typically only in the finish coats. A fingernail can't feel the ridge.
- Deep scratches are typically through the finish coats and have torn the wood fibers.
- Cross-grain scratches are deep scratches, and are oriented perpendicular to the direction of the flooring, often crossing multiple board widths and have a higher probability of exhibiting wood fiber tear. Deep scratches, usually termed "gouges," are typically through the finish coats and have torn the wood fibers.
- As scratch damage increases in severity, so does the likelihood that the damage will also include denting.
- **Indentations** - notches, grooves or depressions on the surface of the flooring.

- Indentations are caused by applied vertical and/or horizontal forces on the flooring surface.
- When only vertical forces have been applied (dropping an object) these depressions are typically isolated to the shape of the portion of the dropped object that contacted the floor.
- Indentations may not always be accompanied with finish tear/fracture.

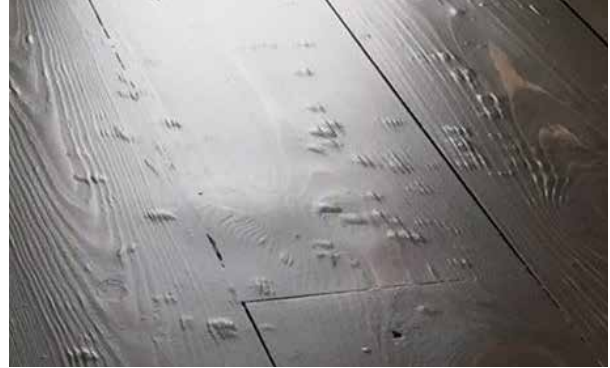
- **Wood bruises** - from a previous force or trauma to the surface of the boards that is not normally noticeable during the installation or handling of the product. This damage can become exposed with an increase in moisture, such as with the introduction of water through water-popping, water-based finishes, water-based stains, or similar reactive conditioners.

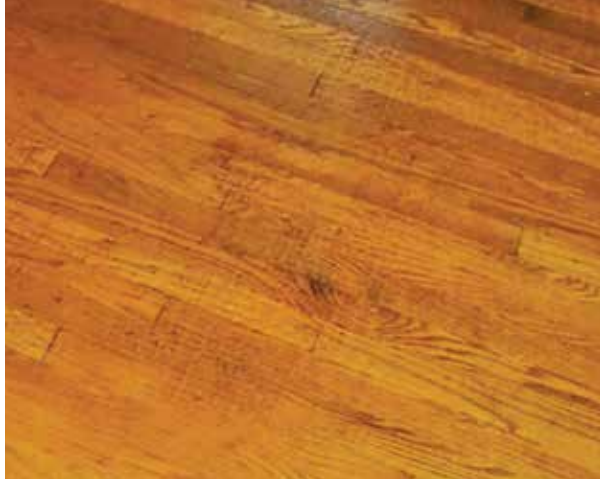
## Surface Impressions

**DEFINITION:** A shape or pattern imprinted on the face of the board, which resembles an item or object that had been in direct contact with it.

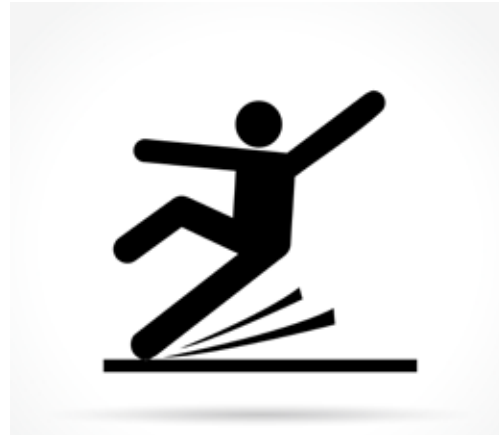
## Slippery Floors

**DEFINITION:** The perception that the floor feels slippery. All wood floor finishes could be considered slippery with normal use. Most wood floor finishes are not usually considered to be slip-resistant, and some wood floor finishes feel slipperier than others.
